#### PERFORMANCE TEST REPORT

### TREMCO INC.

**SERIES/MODEL:** Proglaze ETA - System 3 **PRODUCT TYPE:** Pre-Engineered Air Barrier Transition Assembly

Report No.: 92938.01-109-44
Revision 1: 08/21/09
Test Date: 07/09/09
Report Date: 07/23/09
Expiration Date: 07/09/13

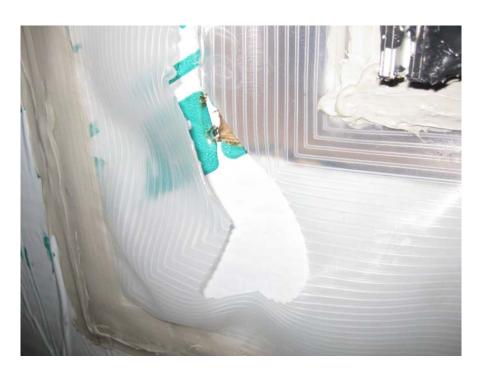
**Note**: The system passed +175 psf load, but after 9 seconds at -175 psf the lower left molded corner (viewing from the outside) of the window unit ripped open.

Photo No. 5 Failure of Membrane During -175 psf Structural Load
