PERFORMANCE TEST REPORT

TREMCO INC.

SERIES/MODEL: Proglaze ETA - System 3

Report No.: 92938.01-109-44
Revision 1: 08/21/09
Test Date: 07/09/09
Report Date: 07/23/09
Expiration Date: 07/09/13

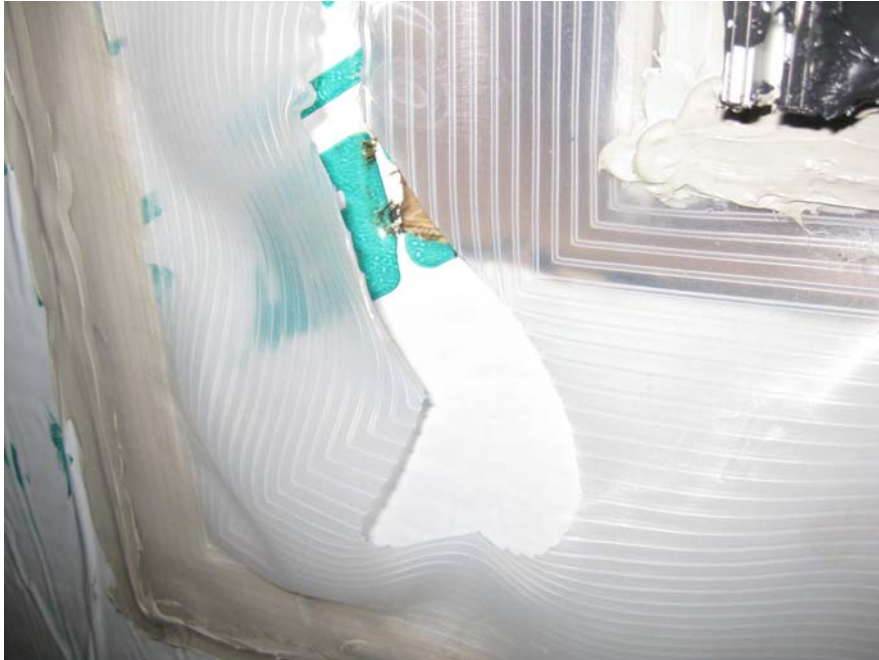
Note: The system passed +175 psf load, but after 9 seconds at -175 psf the lower left molded corner (viewing from the outside) of the window unit ripped open.

Photo No. 5
Failure of Membrane During -175 psf Structural Load
