Spectrem Simple Seal

Detail: Spectrem Simple Seal at Inside/Outside Corners

SSS-C-01

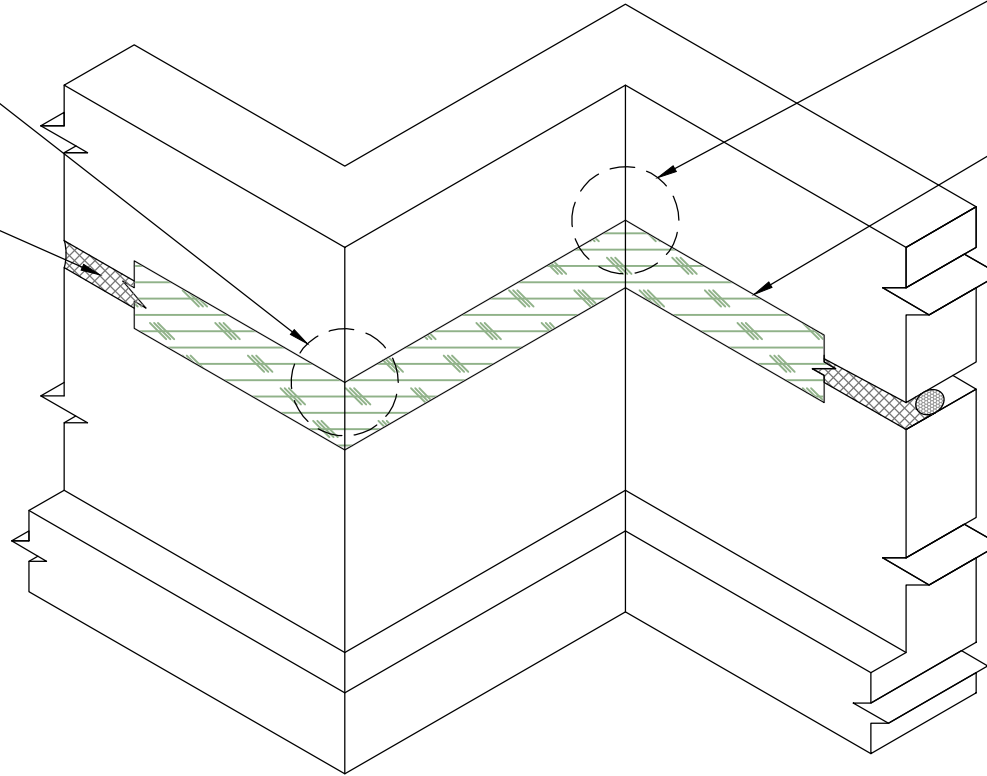
EXISTING FAILED JOINT SEALANT

SPECTREM SIMPLE SEAL

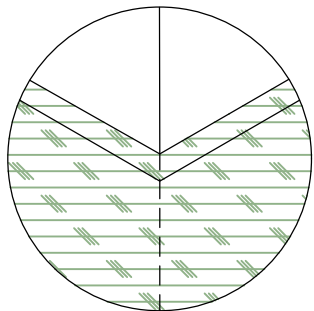
DETAIL A
OUTSIDE CORNER
WRAP AROUND

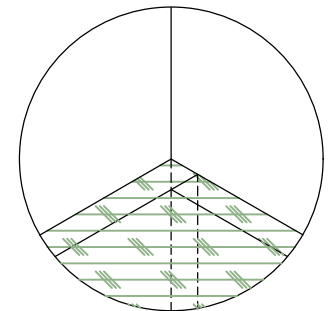
DETAIL B
INSIDE CORNER
BUTT JOINT
