The Challenge of Integrating Building Components

Is building envelope integrity at risk?

by Edward J. Retzbach, CSI, CDT

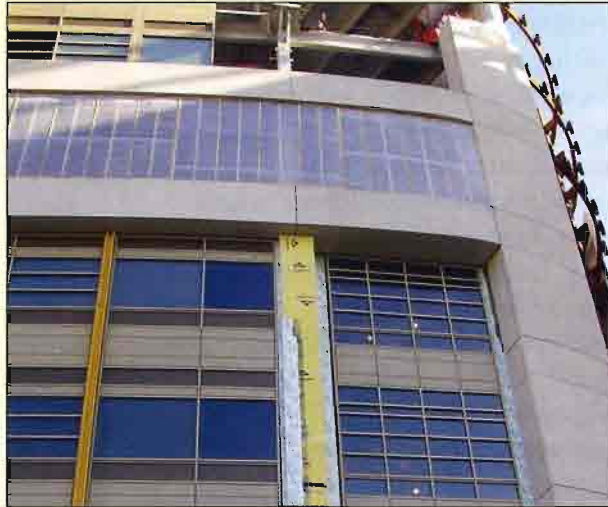
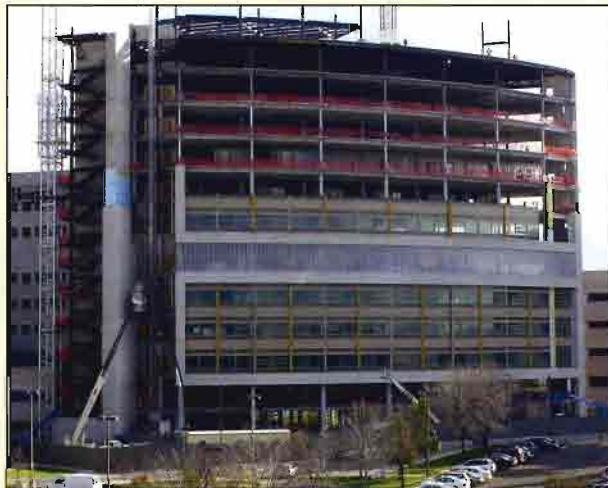
The Children's Hospital of Wisconsin (Milwaukee) was recently expanded with the addition of a 12-story tower. A main concern was the design and installation of an effective exterior façade; engineered transitions helped ensure compatibility.

The Children's Hospital of Wisconsin (Milwaukee) was recently expanded with the addition of a 12-story, 39,484-m² (425,000-sf) tower for patient rooms, a larger pediatric intensive care unit (ICU), and an expanded Herma Heart Center. A main concern for the \$165-million project was the design and installation of an exterior façade that would not allow moisture or condensation to form within the building.

Areas where dissimilar components meet (*i.e.* curtain wall and various adjacent wall assemblies) normally involve multiple installers. Maintaining control at these intersections to avoid moisture infiltration and potential for mold growth was paramount. Consequently, a single-sourced engineered transition assembly was used to eliminate the possibility of applicator variations.

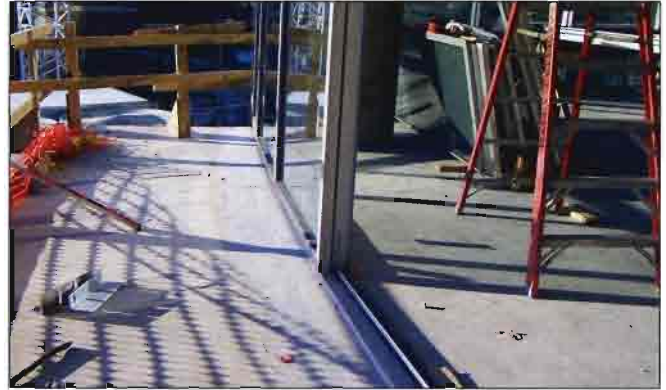
Silicone sealant used at all sill locations, jambs, and head of slider doors must be compatible with urethane deck coatings on balconies and patios to ensure a continuous weatherproof seal.

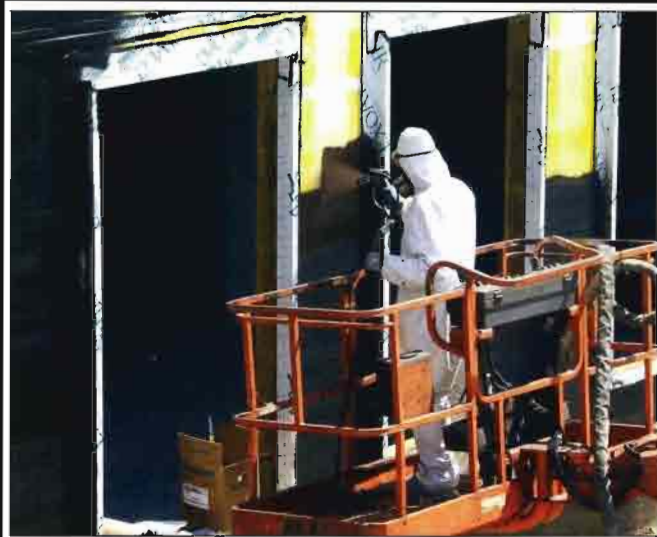
An acetone spray adhesive approved for use to mount window systems into a rough opening with an air barrier system resulted in a softening and deterioration of the air barrier membrane. Once discovered, the air barrier supplier's technical sales representative worked with the window installer on appropriate detailing and provided a sealant tested by the manufacturer to ensure a compatible, single-source system solution.

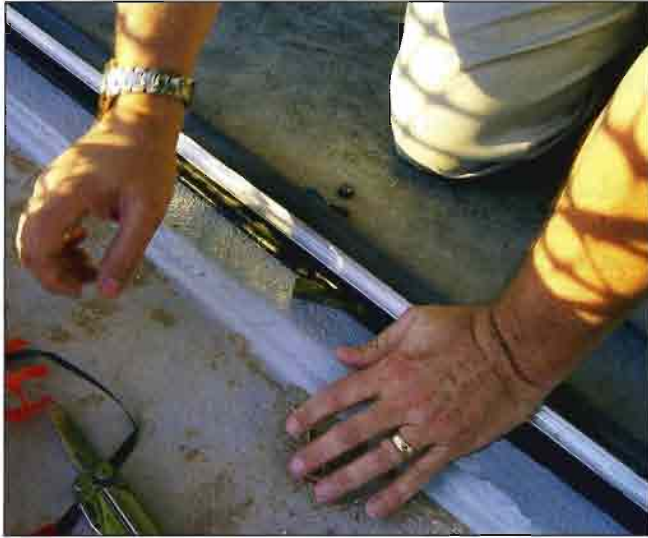
Effective specifications require field adhesion testing by the manufacturer and contractor to confirm surface preparation is adequate and materials will adhere under field conditions. The price of envelope failures makes this prudence necessary.

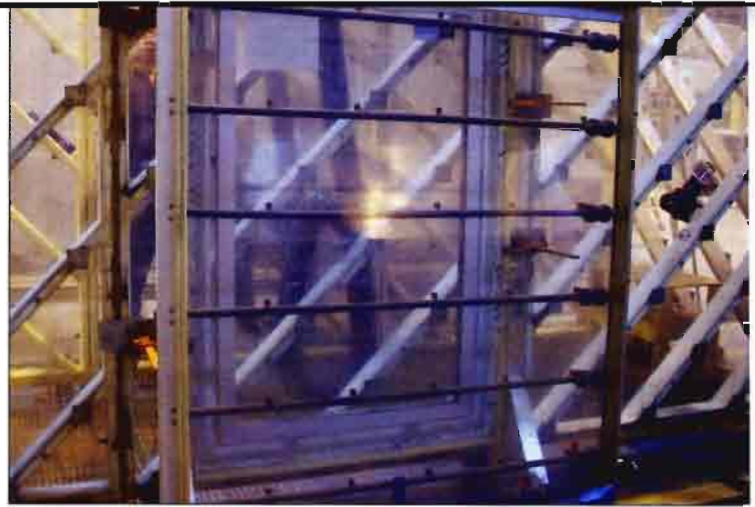
After an engineered transition assembly is tested for air penetration, a water spray rack is moved in front of the assembly. Water is sprayed at a prescribed volume while the window is subjected to negative air pressure (i.e. positive load), looking for any water penetration.
