Hyatt Regency Chicago - Protecting the Brand

QUALITY OF THE EXPERIENCE MAY BE DEPENDENT UPON THWARTING MOISTURE INTRUSION

EXTRUDED SILICONE OVERLAY SYSTEM PROVIDES LEAK-FREE, AESTHETICALLY APPEALING SOLUTION

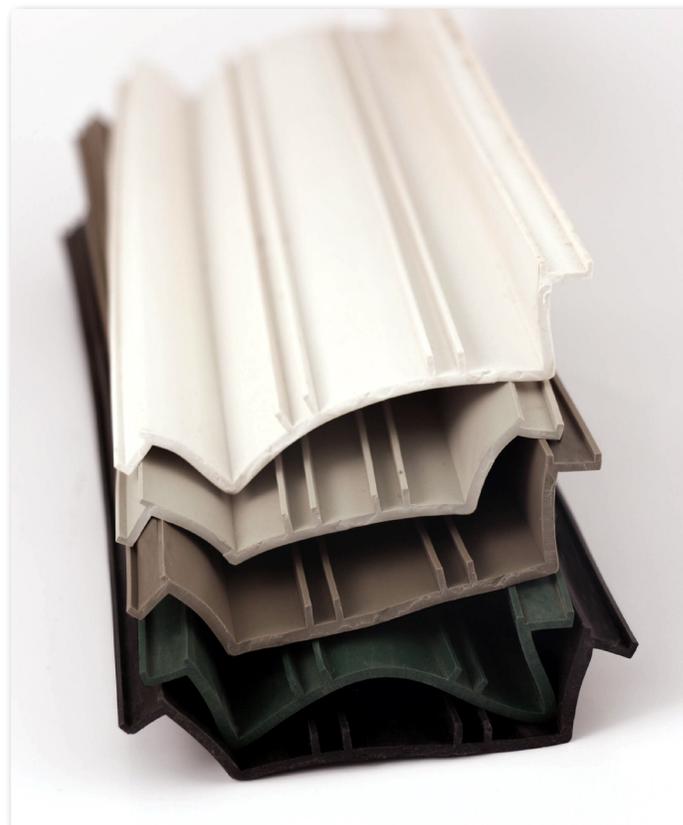
The patented design of the Spectrem Restoration Overlay provides an easy-to-install, aesthetically pleasing, durable solution to restore weather-tightness to skylights, glass paneled roofs, sloped glazing systems, pressure bar and zipper/lockstrip gasket systems.

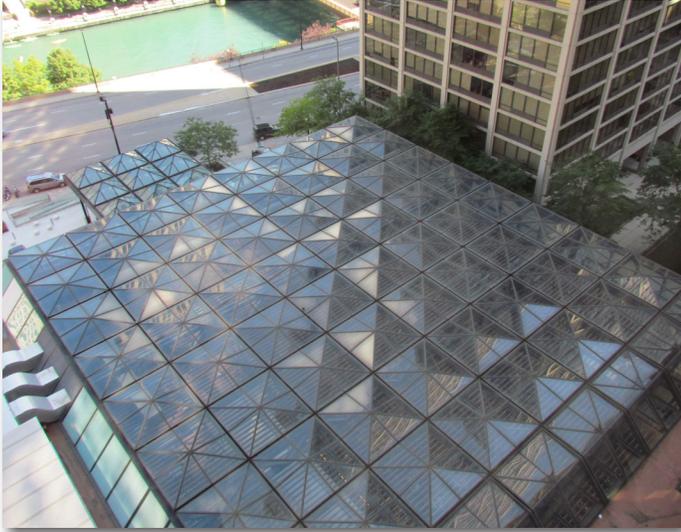
Expansion and contraction from changing weather conditions throughout the day and night on this skylight over an atrium lobby at Hyatt Regency Chicago began to take its toll on glazing seals, creating the potential for leaks along the framework of the glass.

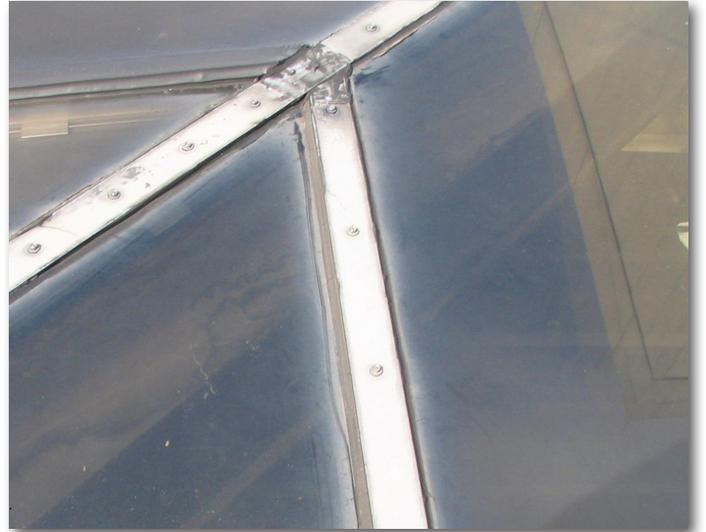
Recaulking over the years had not stopped the leaks and left a slightly messy appearance. Installation of the patented silicone gasket overlay system over the upper left portion of the skylight framework provided a clean appearance while eliminating potential for leaks.

With the extruded silicone overlay system, there is no need to remove the existing sealant. The silicone extrusion is simply applied over the existing joint connecting assembly and is attached to the glass with silicone sealant. A bead of the silicone sealant is applied underneath the outer edges of the extrusion to set the system in place and ensure the water and weather is kept out for the long haul. The fast curing time of the silicone sealant allows a system installed in the morning to form a chemical bond and set up sufficiently to handle the expansion occurring with the heat of the afternoon and the contraction of the cool night, a factor essential to a secure seal. To ensure a secure bond to the glass,

the patented silicone extrusion incorporates a footing into the assembly for encapsulation of the silicone sealant bead for an extra layer of protection and assurance of a unified seal that fits snugly over the existing system. Without having to remove old sealant, additional steps to provide a clean surface and tooling of new caulk are eliminated.

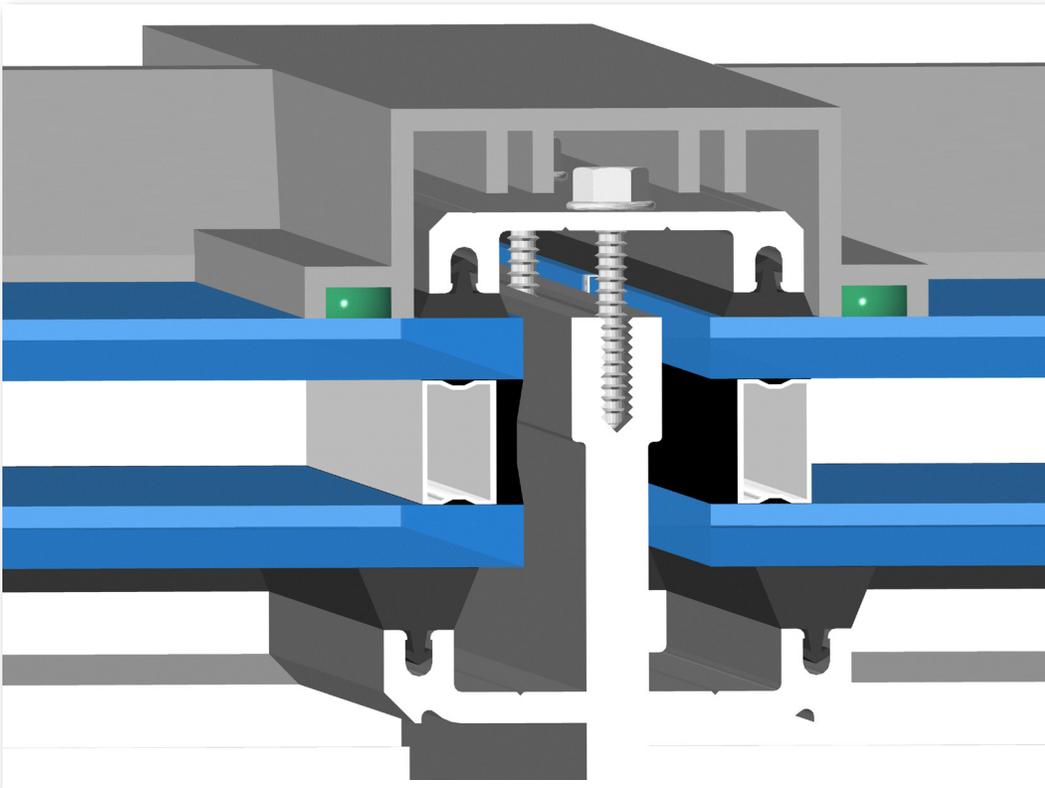
The patented design of Tremco's Spectrem (R) Restoration Overlay allows it to encapsulate leaking purlins while completely enclosing the silicone sealant bead. The result is a clean, aesthetically pleasing appearance plus an extra layer of protection that shields the sealant bead from exposure to the elements and eliminates air and moisture penetration.
