Pennsylvania Capitol East Wing

Challenge: Classic Majesty of Pennsylvania Capitol's East Wing Restored

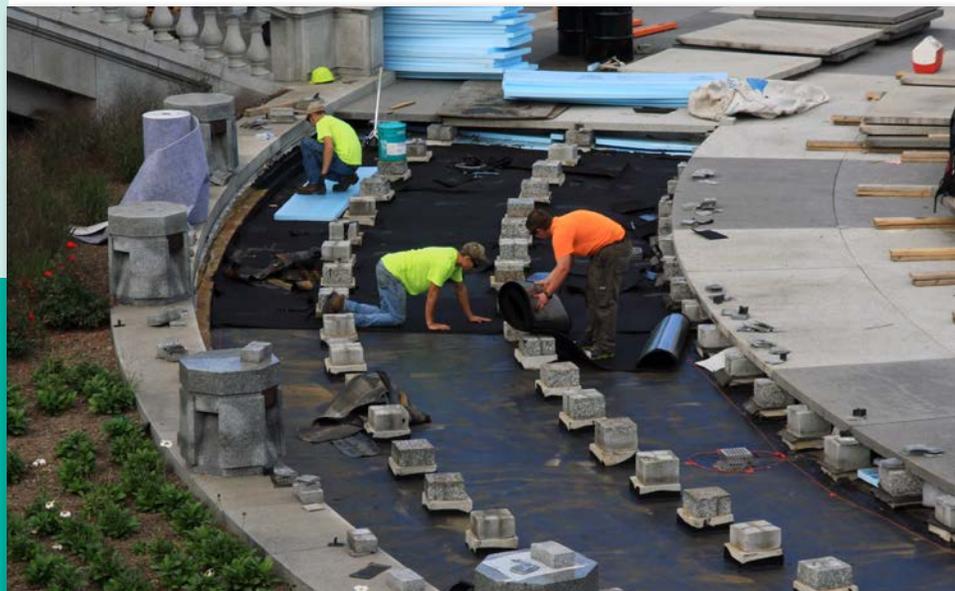
The existing EPDM waterproofing membrane beneath the sloping walkways had to be demolished down to the concrete substrate and replaced with the TREMproof 250GC Cold Fluid-Applied Elastomeric Membrane to provide a seamless water barrier and the elasticity to endure the movement required.

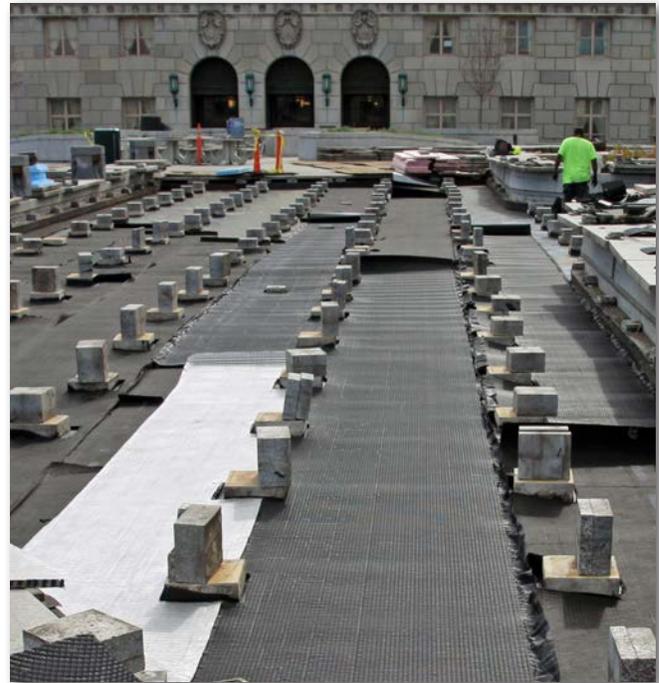
Drainage mat was installed over the TREMproof 250GC, then four-inch foam installation, followed by Tremco Protection Mat for membrane protection from ultraviolet degradation and the rigorous conditions in Harrisburg.

Drainage mat was installed over the waterproofing, then four-inch foam insulation, followed by Tremco Protection Mat. Extremely tough and puncture-resistant, the ultra-lightweight, easy-to-install polyester mat offers excellent membrane protection, making it ideal for even the most rigorous conditions. Tremco Protection Mat is also resistant to ultraviolet degradation.

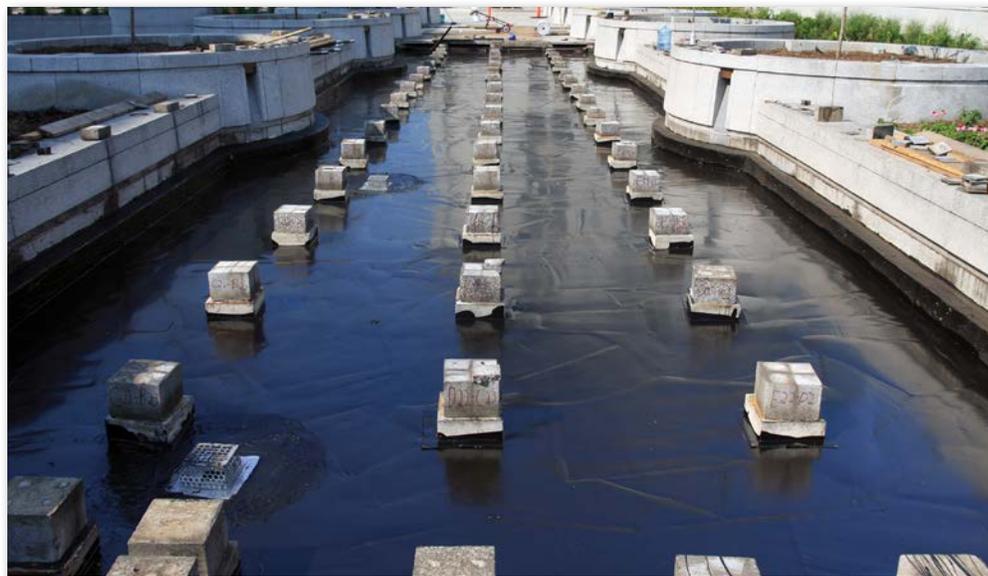
In the paver areas, the TREMproof 250GC would be applied, cured, leak detection was completed and it was ready to be walked on within two days.

Under the granite pavers in the plaza area, the TREMproof 250GC was applied, cured, leak detection was completed and it was ready to walk on within two days. Electronic leak detection was installed everywhere the waterproofing was applied and was left in place. The leak detection system verifies the membrane has no breaches prior to installing the overburden and aids in locating any future breach.

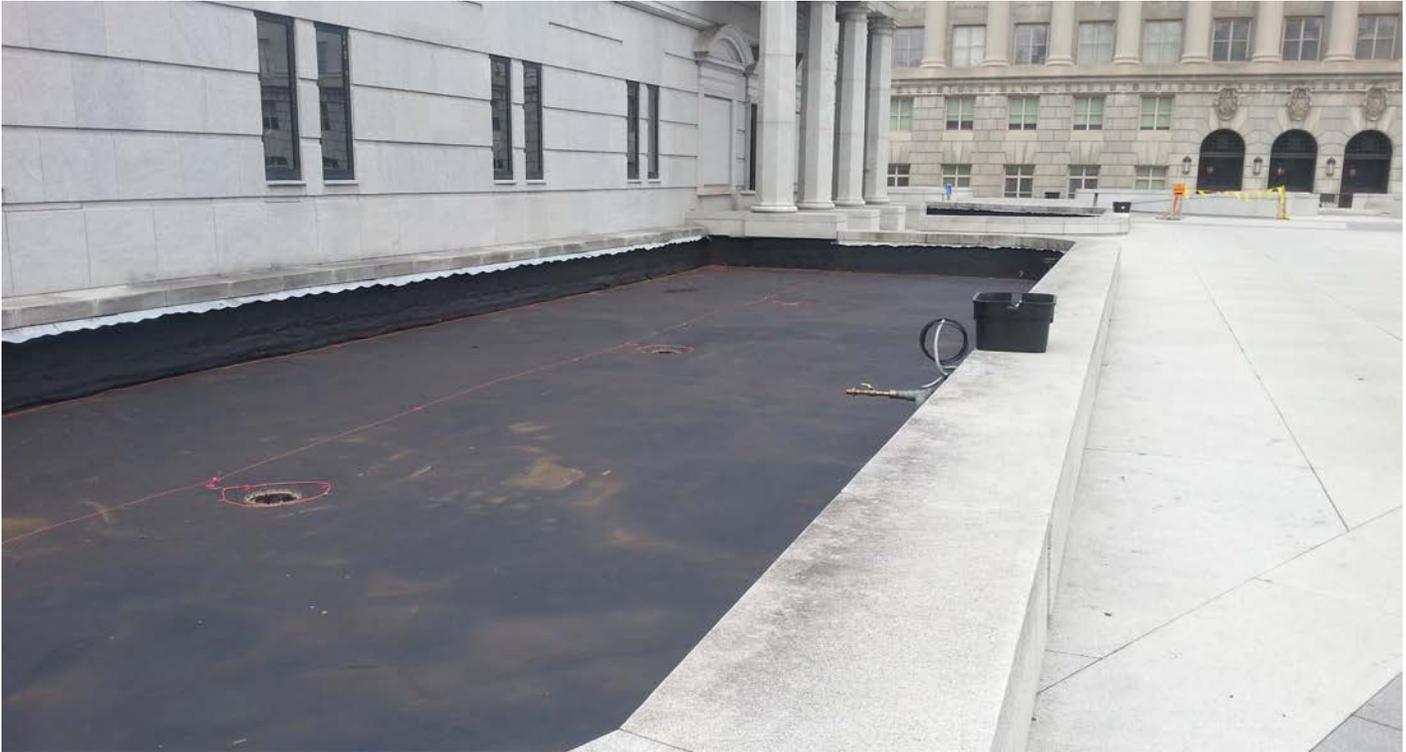
About half of the project included planters and 40,000 square feet of vertical surfaces so the TREMproof 250GC with its trowel-grade version helped to ensure no areas were left untreated or exposed to moisture infiltration. TREMDrain GS drainage mat was used over the membrane to enhance the performance of the waterproofing system by functioning as a water retention layer while designed to also prevent root growth.

With just about half of the project involving planters, the fluid-applied membrane helped to ensure the planters were properly waterproofed and no areas were left untreated or exposed to moisture infiltration. To protect the membrane from damage during backfilling or garden maintenance while enhancing the performance of the waterproofing system, TREMDrain Drainage Mat was installed over the membrane, followed by 4-inch foam board insulation, another drainage mat and then the trees and shrubs. TREMDrain® GS drainage mat consists of a perforated polystyrene core with fabrics attached to both sides so the roots would not sit in water. Installed with the dimples down, the core also functions as a water retention layer. It also includes a copper hydroxide treatment to prevent root growth within the mat's cone.
