# PROJECT PROFILE:

**Point of France Condominiums**  
*Edina, MN*

## Preformed Silicone Extrusions Provide Effective, Attractive Restoration of Window Perimeters

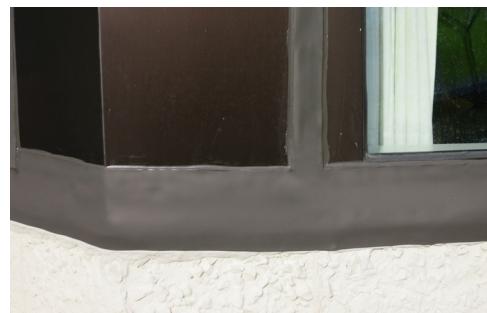
Sealant Joints After

Spectrem 2 Silicone Sealant was applied to each side of the area to be sealed with beads large enough to encapsulate the width of the ridges on each side of the extrusion for a secure bond when embedded into the wet sealant. The new seal is then placed right over the top of the old or failed sealant or caulk without having to scrape and dig out the old material, risking damage to the joint and substrate. Off-white sealant was used at the stucco and then rolled to give it texture. Particularly where the joint design and size are improper, the precured silicone extrusion will extend the life of the restoration. The silicone formulation also is resistant to UV exposure and weathering, so it will resist fading for decades.

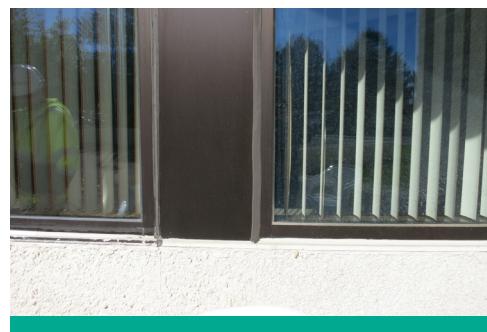
of Quast. "The joint design was creating problems. The metal flashing was lapping over the face of the headstarter and did not have a backer rod or bond breaker tape. This in turn did not allow for thermal movements and caused sealant failures. At the corners where the window meets the vertical break metal, the flashing was most vulnerable."

"The vertical joints weren't properly sized and didn't have a return, Denton added. "Caulking requires 1/4-inch adhesion surface, but there was 1/8-inch or less. We would have had to use a bond breaker tape and apply the sealant onto the face of the frame."

Sealant Joints Before

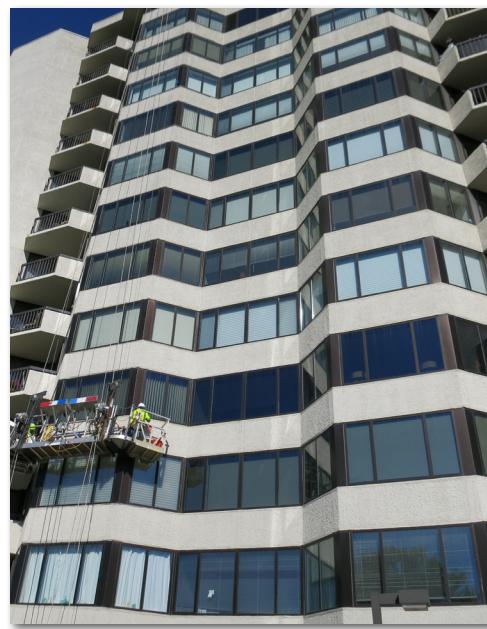
▲  
Spectrem Simple Seal provided a cost-effective solution that enabled the three sealant joints at the head of the window to be covered with one seal.

In order to get a repair that could last 30 years or so, the job originally called for removal and replacement of the sealant. When looking at the conditions, though, the on-site foreman suggested Spectrem Simple Seal as a cost-effective alternative that would enable the three sealant joints at the head of the window to be covered with one seal; it would be aesthetically pleasing and blend in with the stucco façade. Simple Seal accommodates metal-to-metal joints that aren't flush, is highly flexible and allows movement behind it.

Simple Seal bronze was used to match the existing window frames in a 4-inch width for the window head and sills. For the vertical mullions and metal-to-metal joints, 1.5-inch wide material was used.
