ARA-TR-04-16496-1

Explosive Test for the Evaluation of CPFilms, Inc. Window Systems

(Quick-Look Report)

**Applied Research Associates, Inc.
Security Engineering Group
119 Monument Place
Vicksburg, MS 39180**

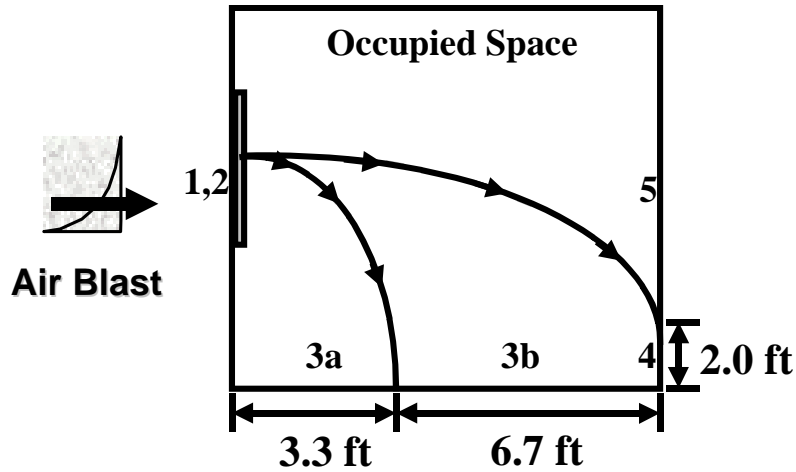
The ISC performance conditions for windows are presented graphically in the figure and described in the table below. The ISC approach compares potential hazards based on the type and location of glass fragments interior and exterior to the test cubicle. These criteria indirectly reflect the velocity (hence hazard level) of fragments based on their distance from the original window position.

Figure 1. Glazing protection levels based on fragment impact locations.

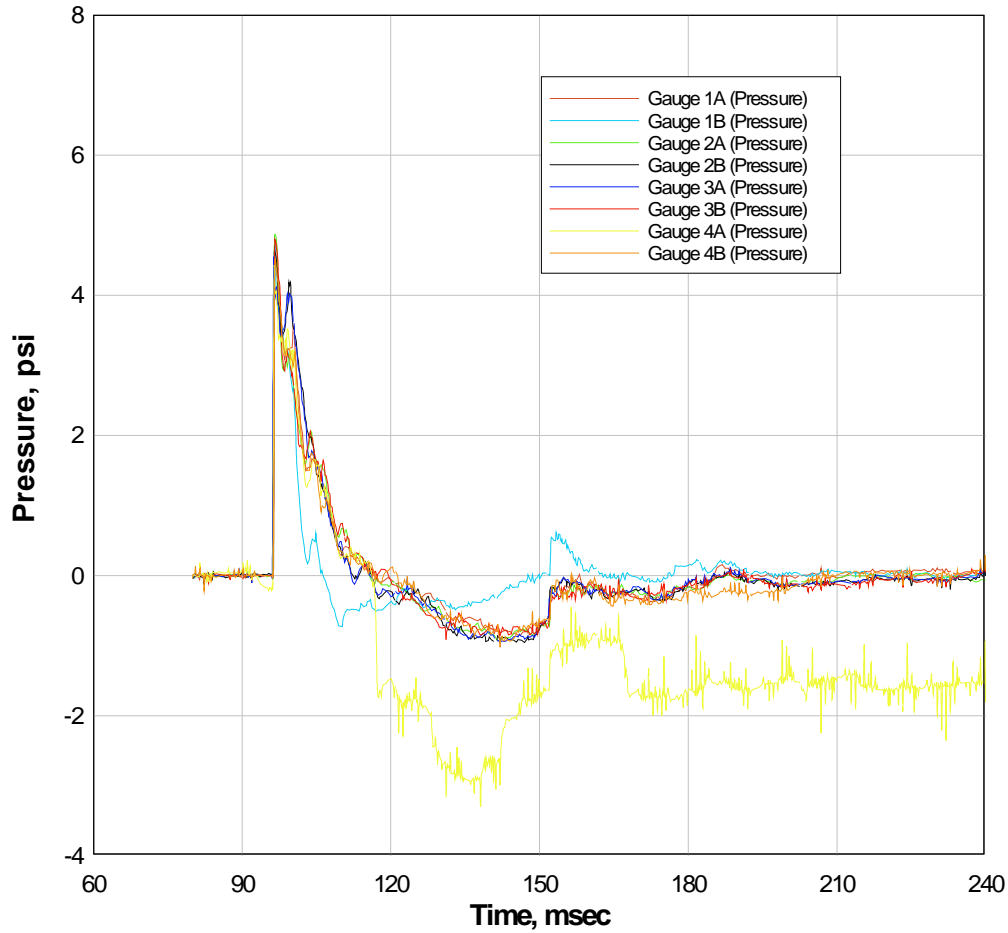
Test 1 - September 20, 2004

Exterior Gauges - Pressure

Figure 19. Test 1 exterior pressure gauges.

Waveforms for each of the gauges are shown in Figure 19 - 34. It should be noted that when attempting to determine the peak pressure and impulses, obvious noise (spikes) in the waveforms were ignored.

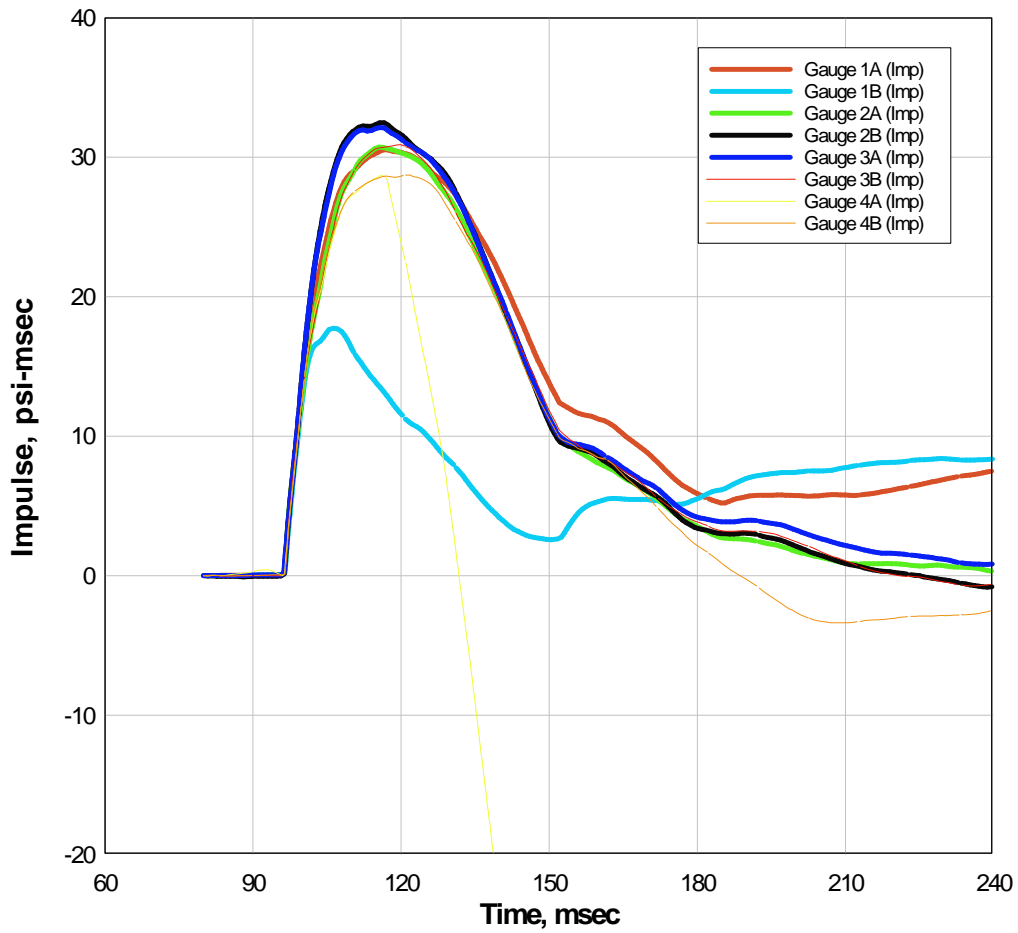
Test 1 - September 20, 2004

Exterior Gauges - Impulse

Figure 20. Test 1 exterior impulse gauges.

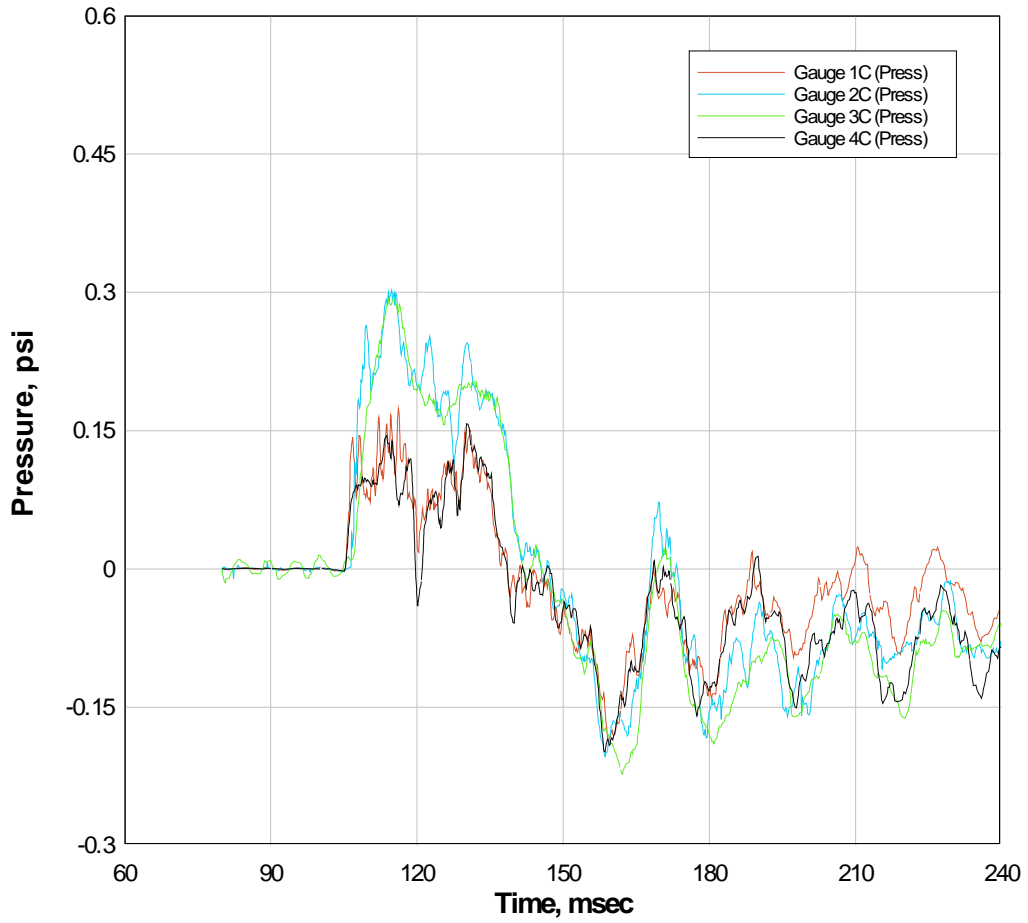
Test 1 - September 20, 2004

Interior Gauges - Pressure

Figure 21. Test 1 interior pressure gauges.

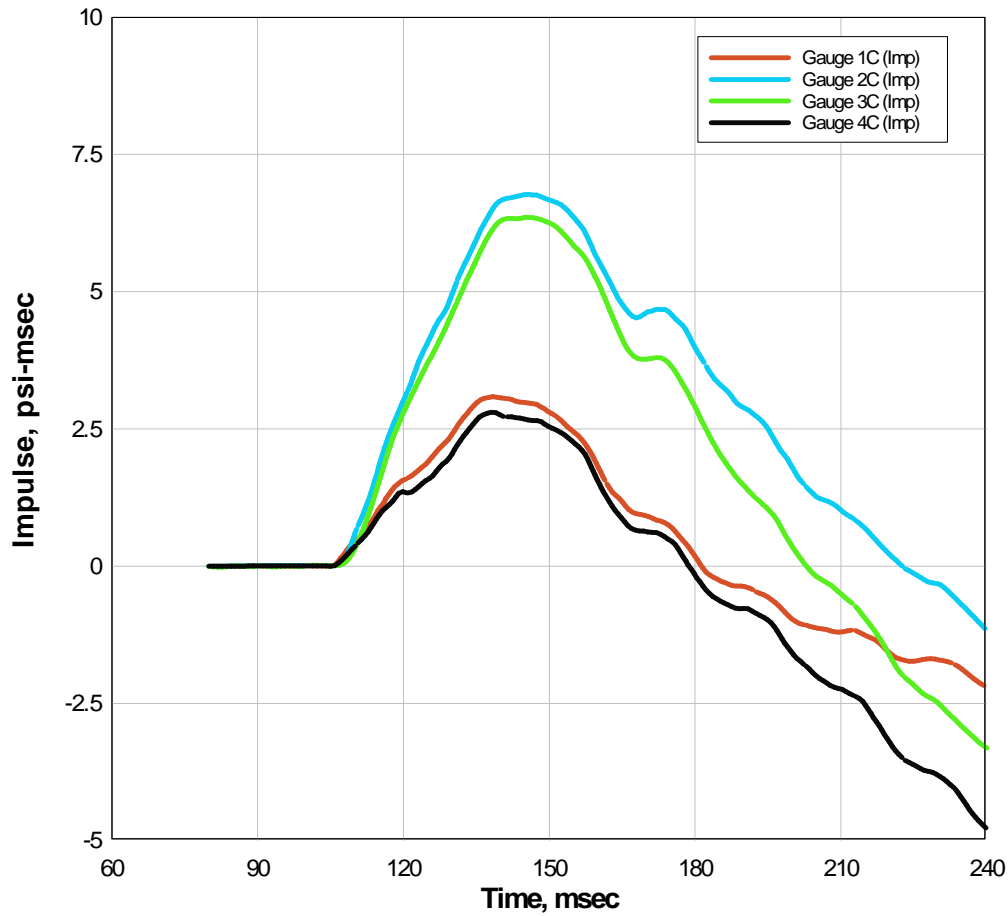
Test 1 - September 20, 2004

Interior Gauges - Impulse

Figure 22. Test 1 interior impulse gauges.

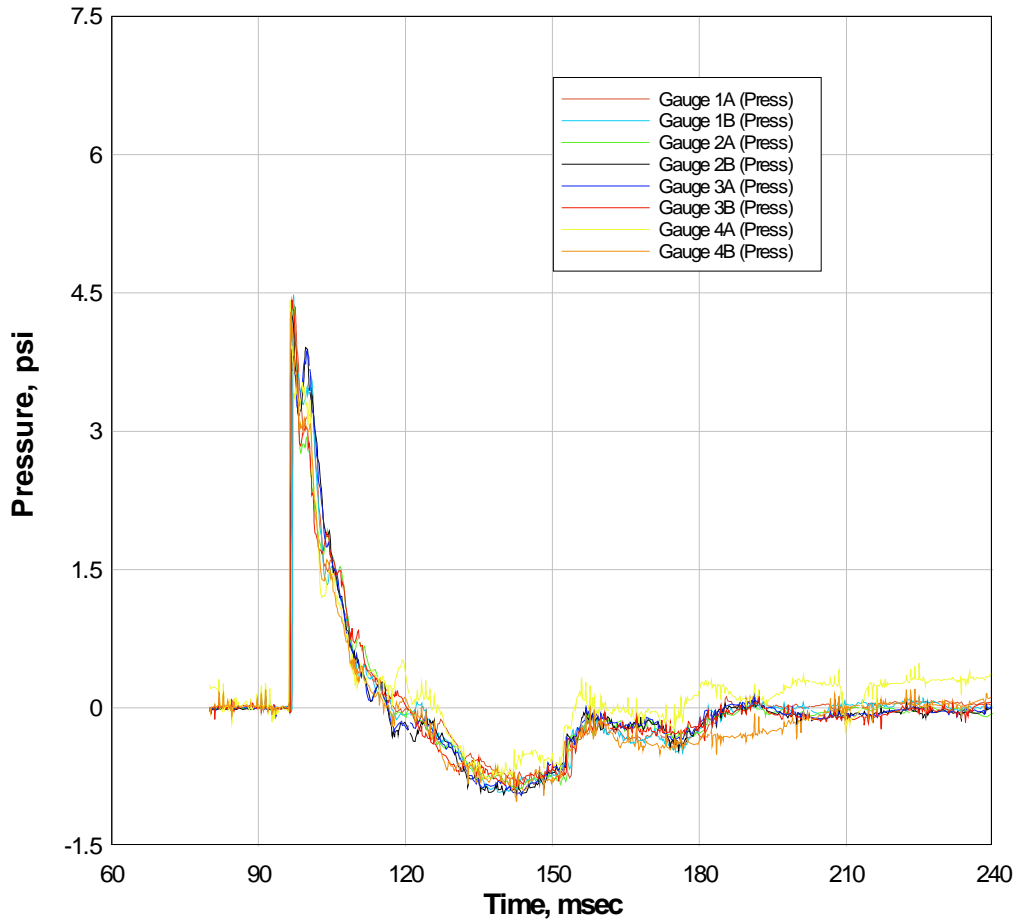
Test 2 - September 20, 2004

Exterior Gauges - Pressure

Figure 23. Test 2 exterior pressure gauges.

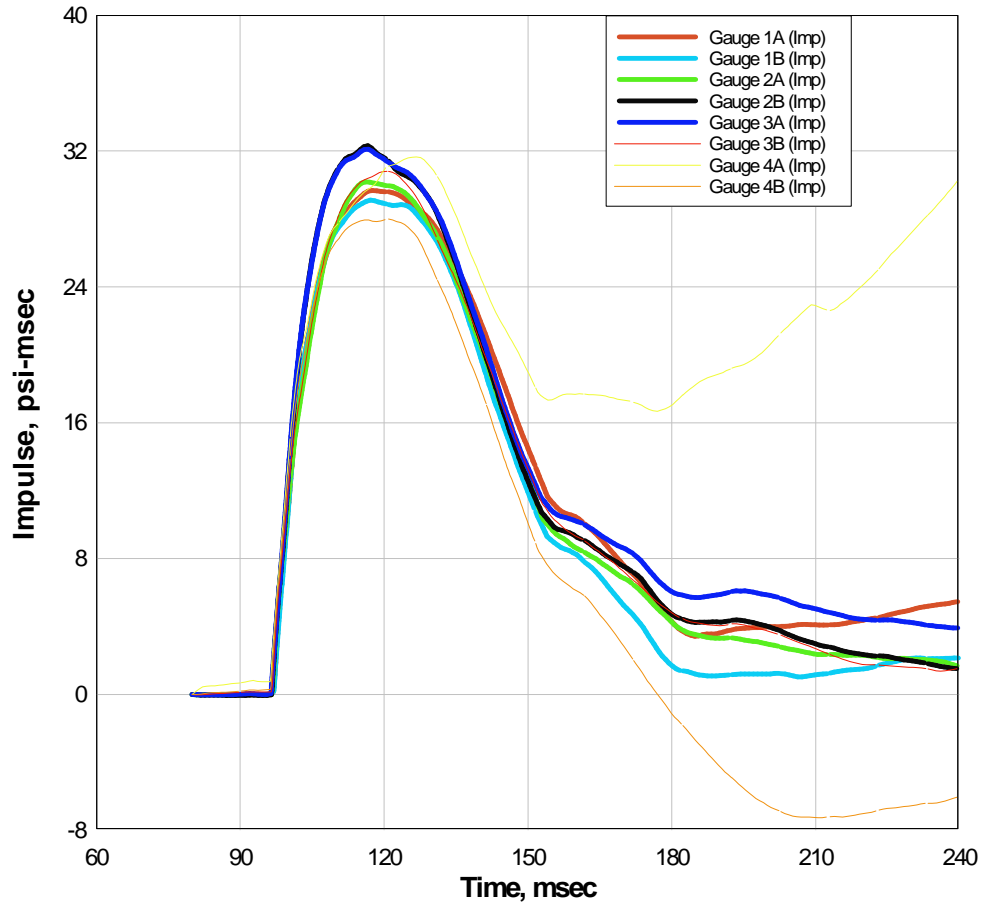
Test 2 - September 20, 2004

Exterior Gauges - Impulse

Figure 24. Test 2 exterior impulse gauges.

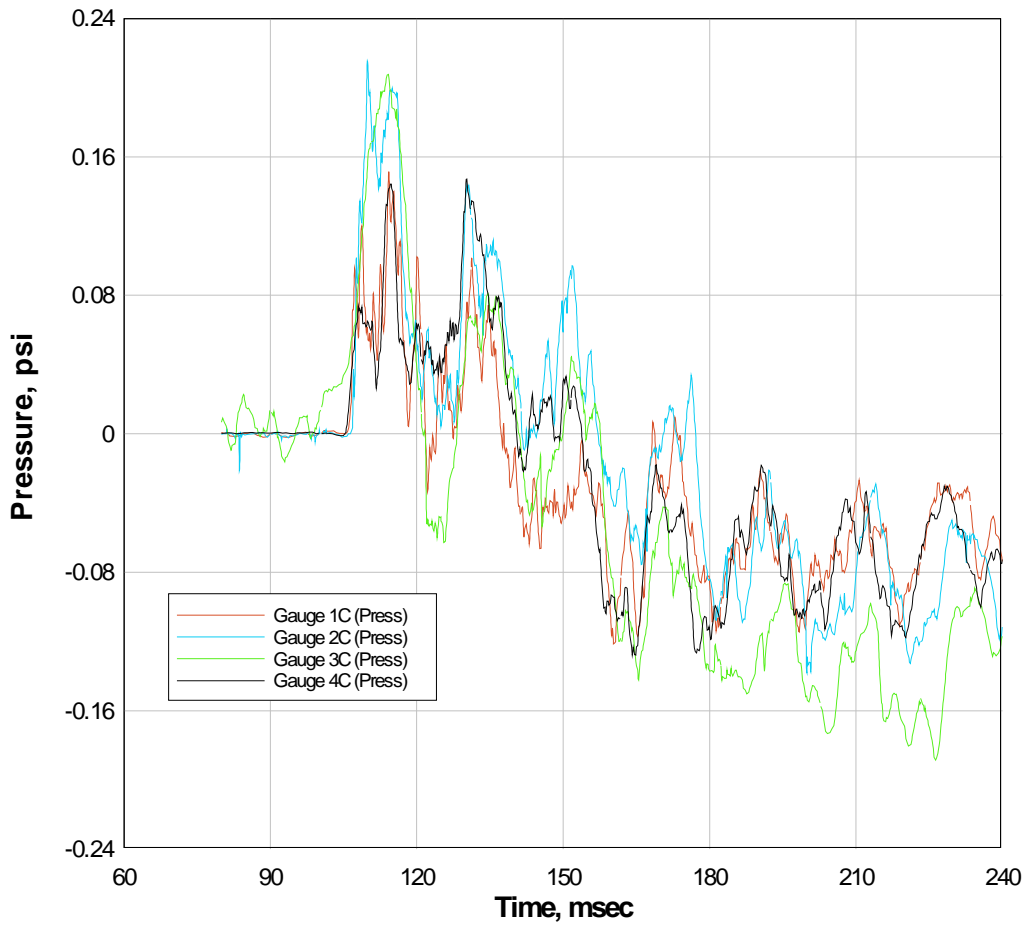
Interior Gauges - Pressure

Figure 25. Test 2 interior pressure gauges.

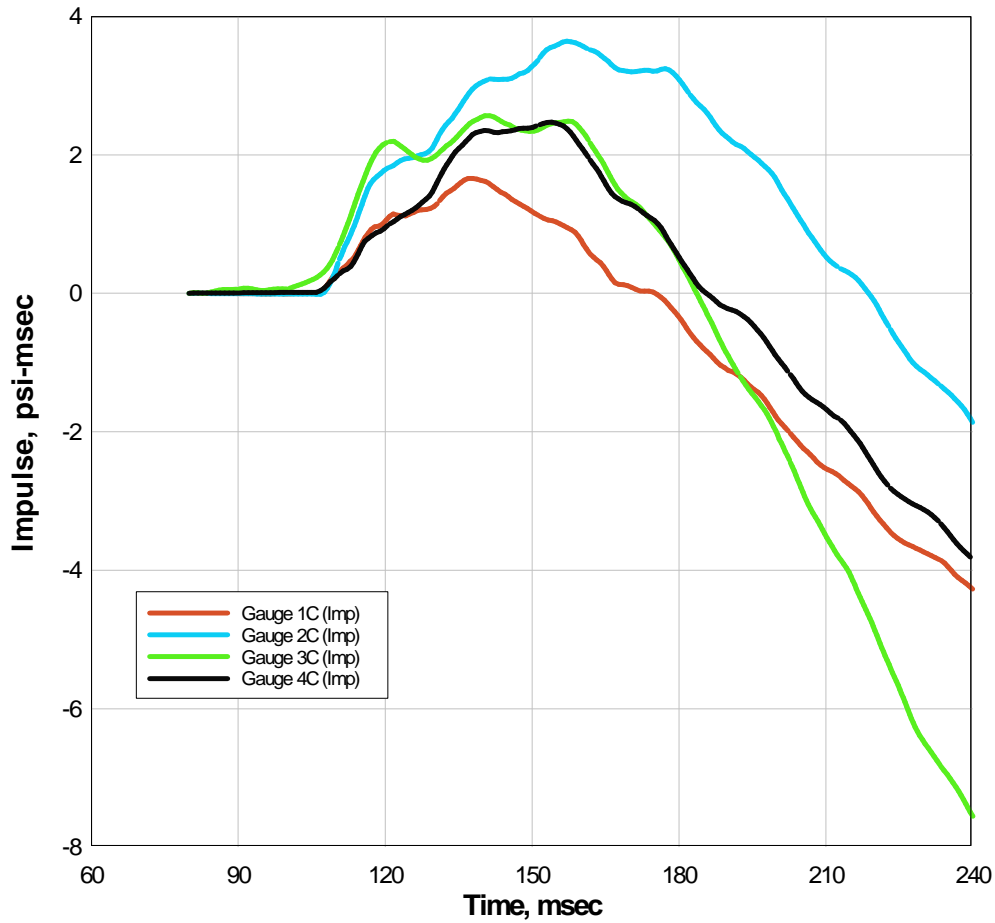
Test 2 - September 20, 2004

Interior Gauges - Impulse

Figure 26. Test 2 interior impulse gauges.

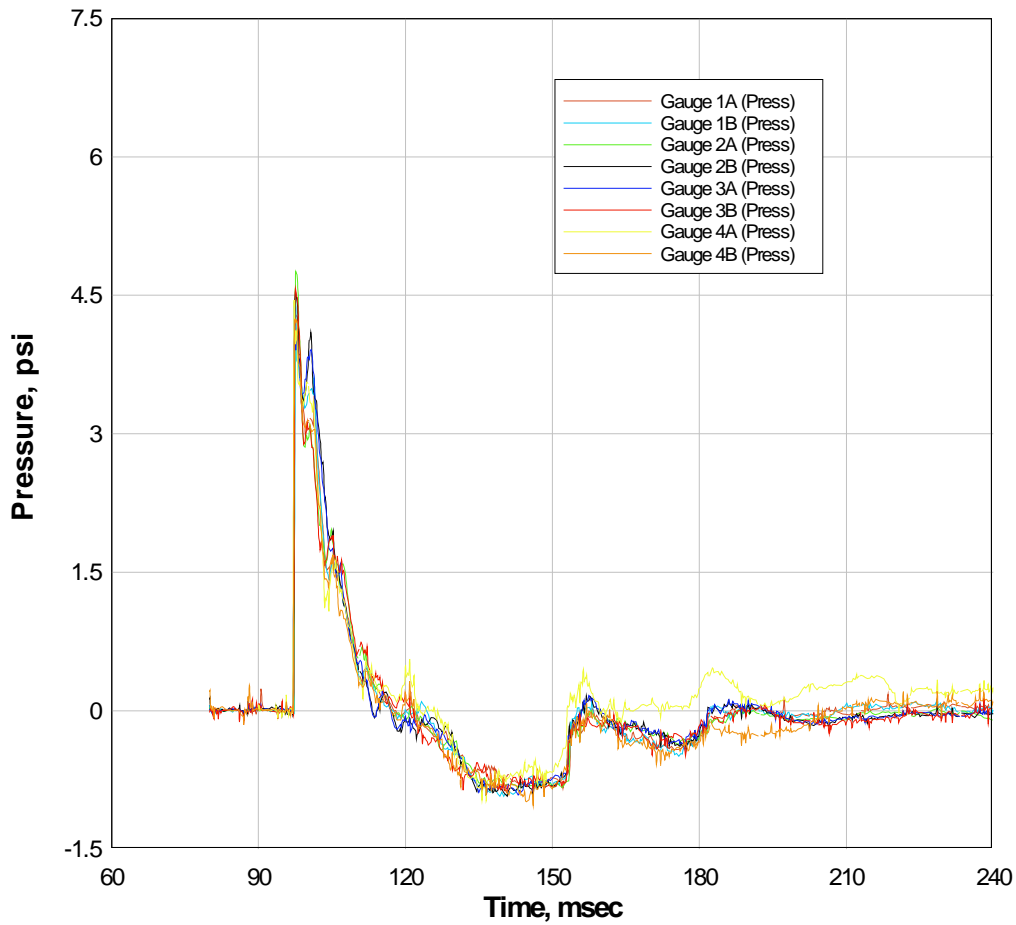
Test 3 - September 21, 2004

Exterior Gauges - Pressure

Figure 27. Test 3 exterior pressure gauges.

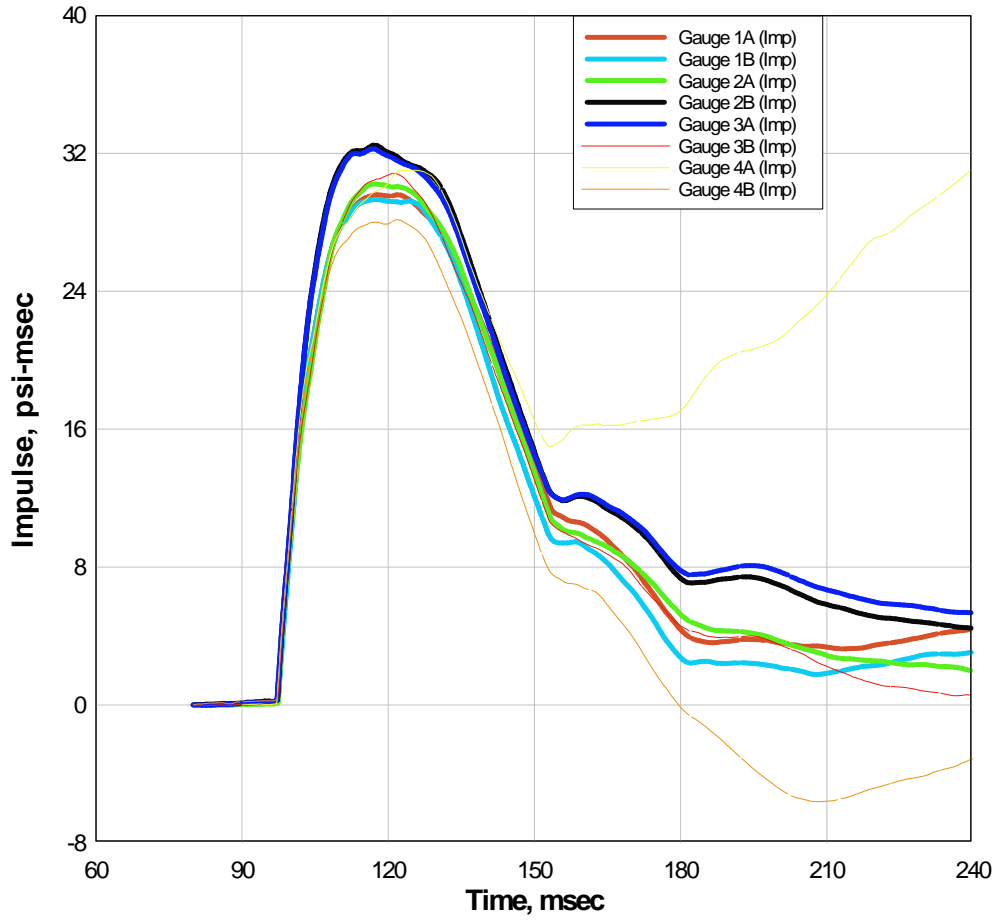
Exterior Gauges - Impulse

Figure 28. Test 3 exterior impulse gauges.

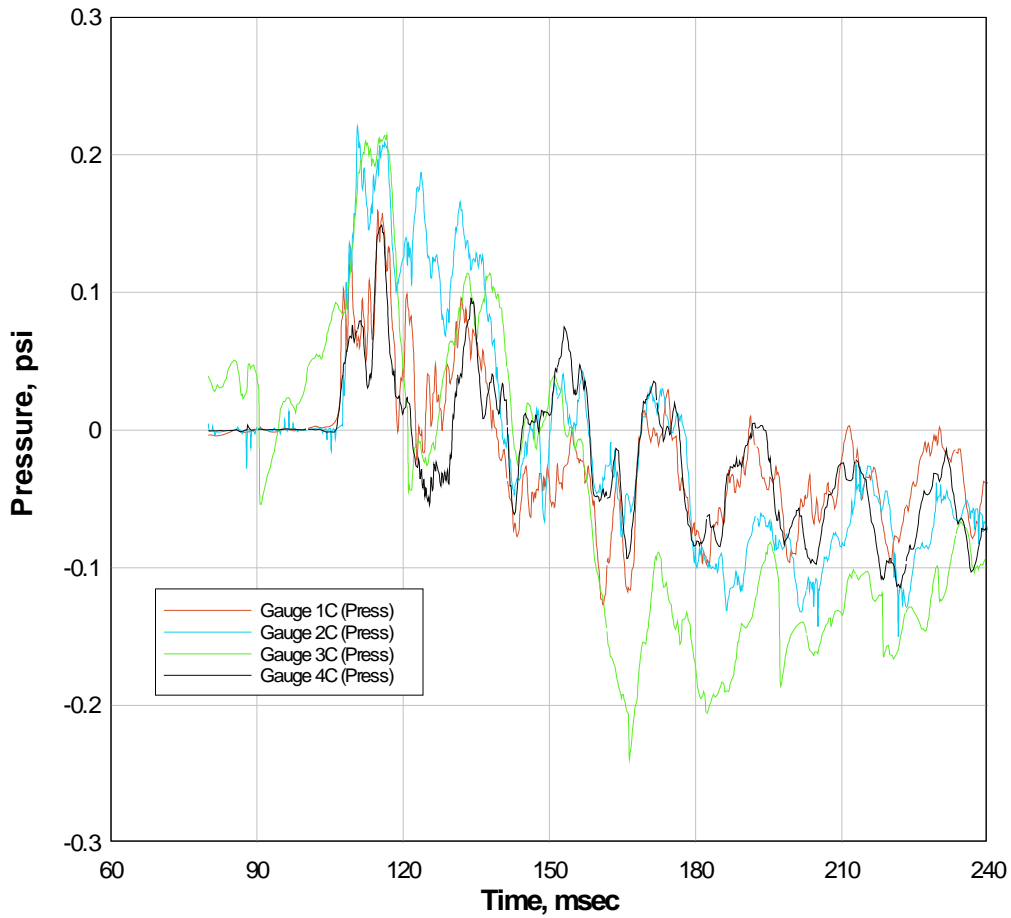
CPFilms Window Tests
Test 3 - September 21, 2004
Interior Gauges - Pressure

Figure 29. Test 3 interior pressure gauges.

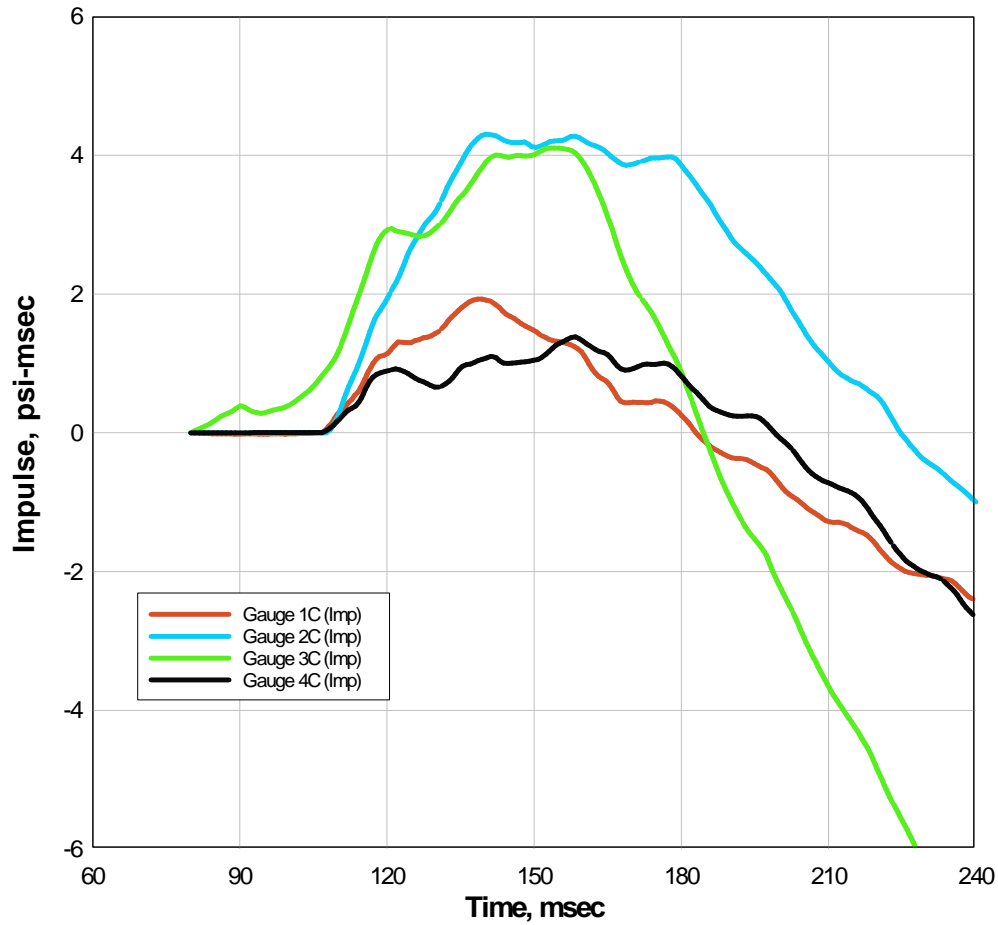
CPFilms Window Tests
Test 3 - September 21, 2004
Interior Gauges - Impulse

Figure 30. Test 3 interior impulse gauges.

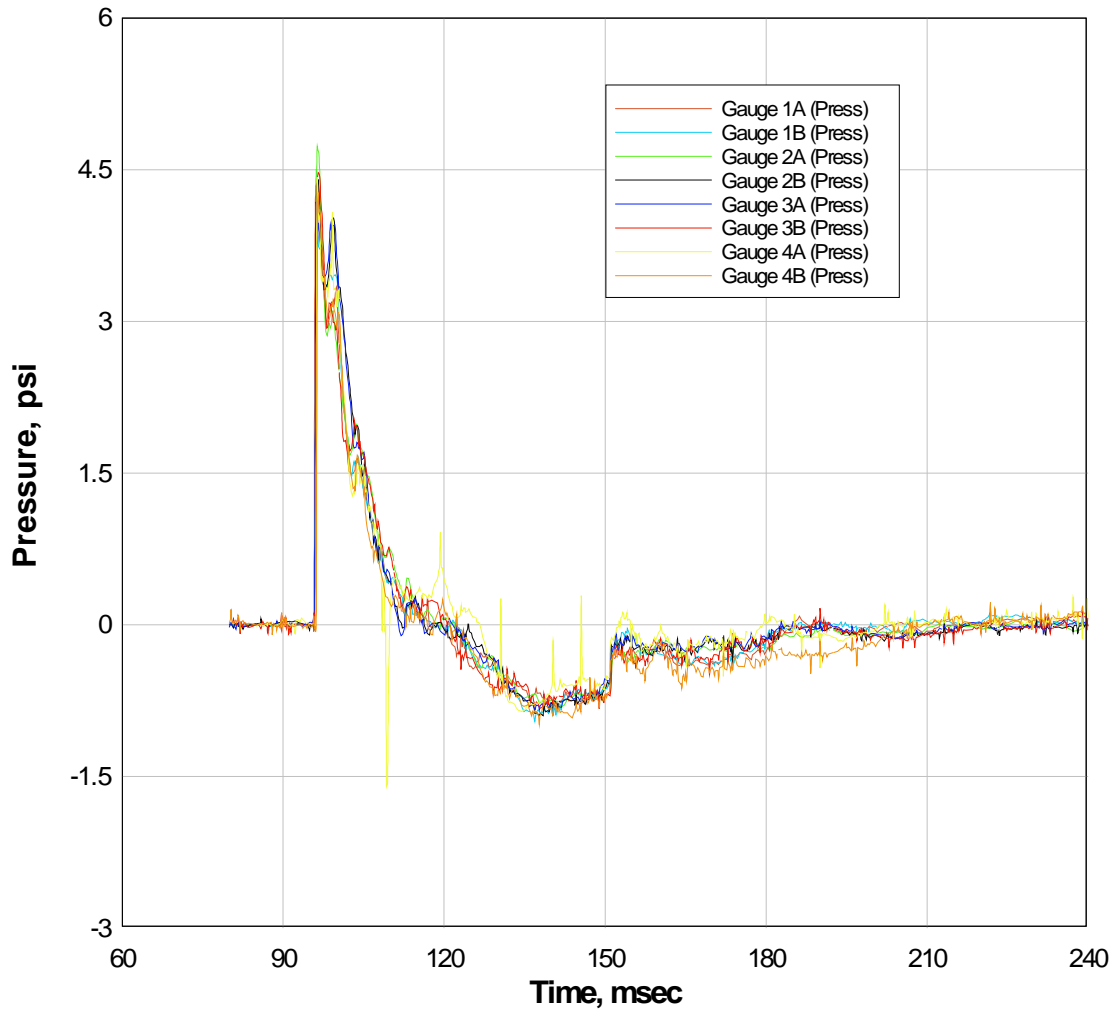
Test 4 - September 21, 2004 Exterior Gauges - Pressure

Figure 31. Test 4 exterior pressure gauges.

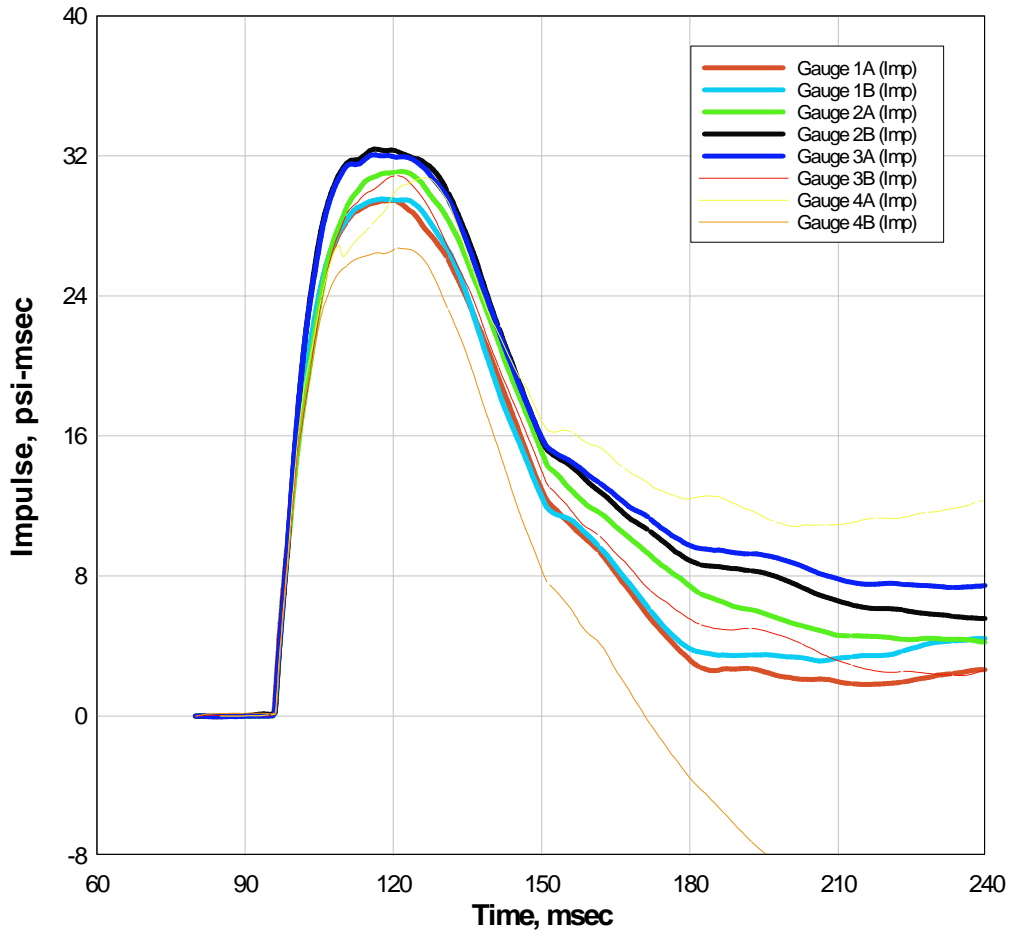
Exterior Gauges - Impulse

Figure 32. Test 4 exterior impulse gauges.

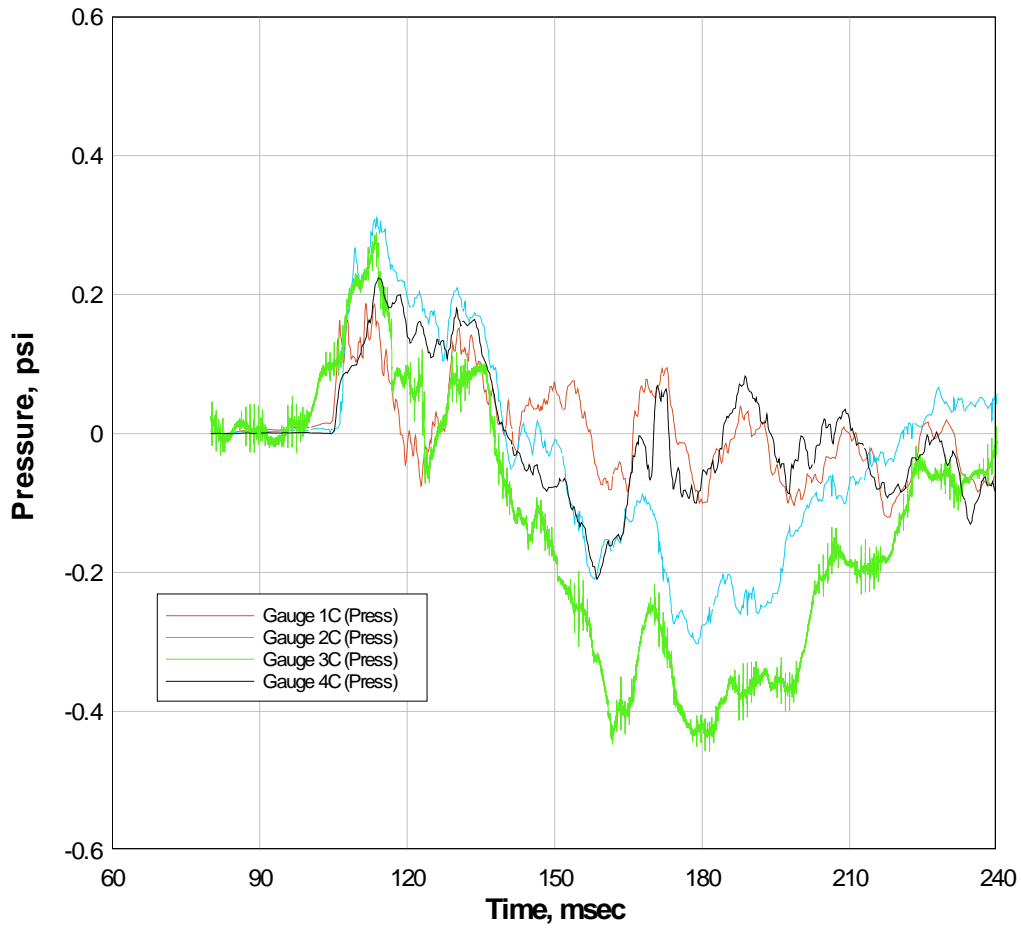
Interior Gauges - Pressure

Figure 33. Test 4 interior pressure gauges.

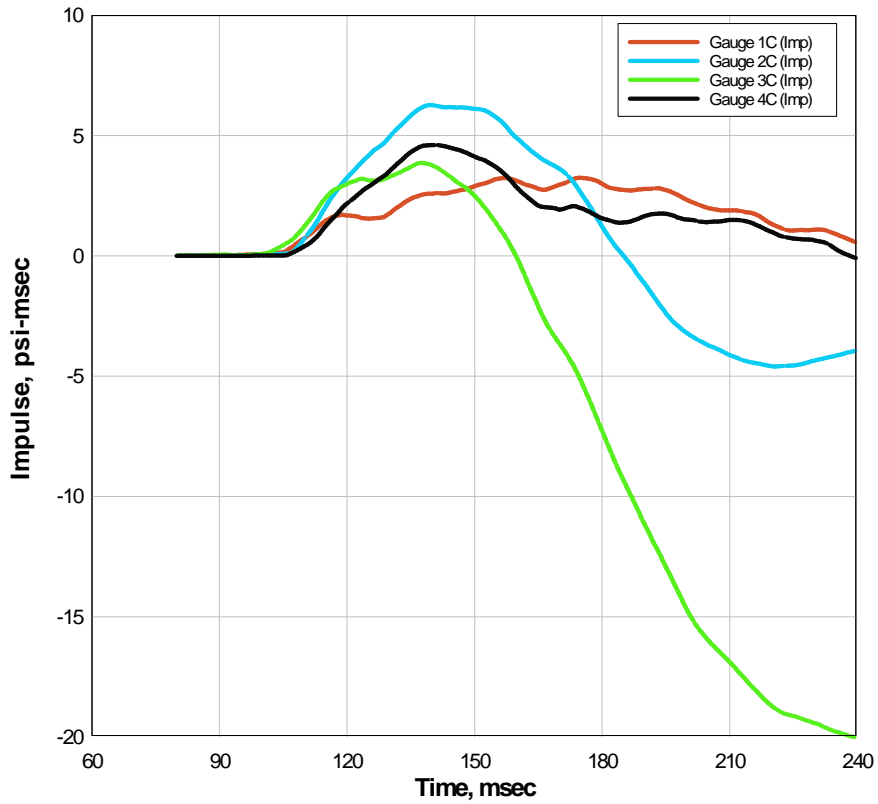
CPFilms Window Tests
Test 4 - September 21, 2004
Interior Gauges - Impulse

Figure 34. Test 4 interior impulse gauges.

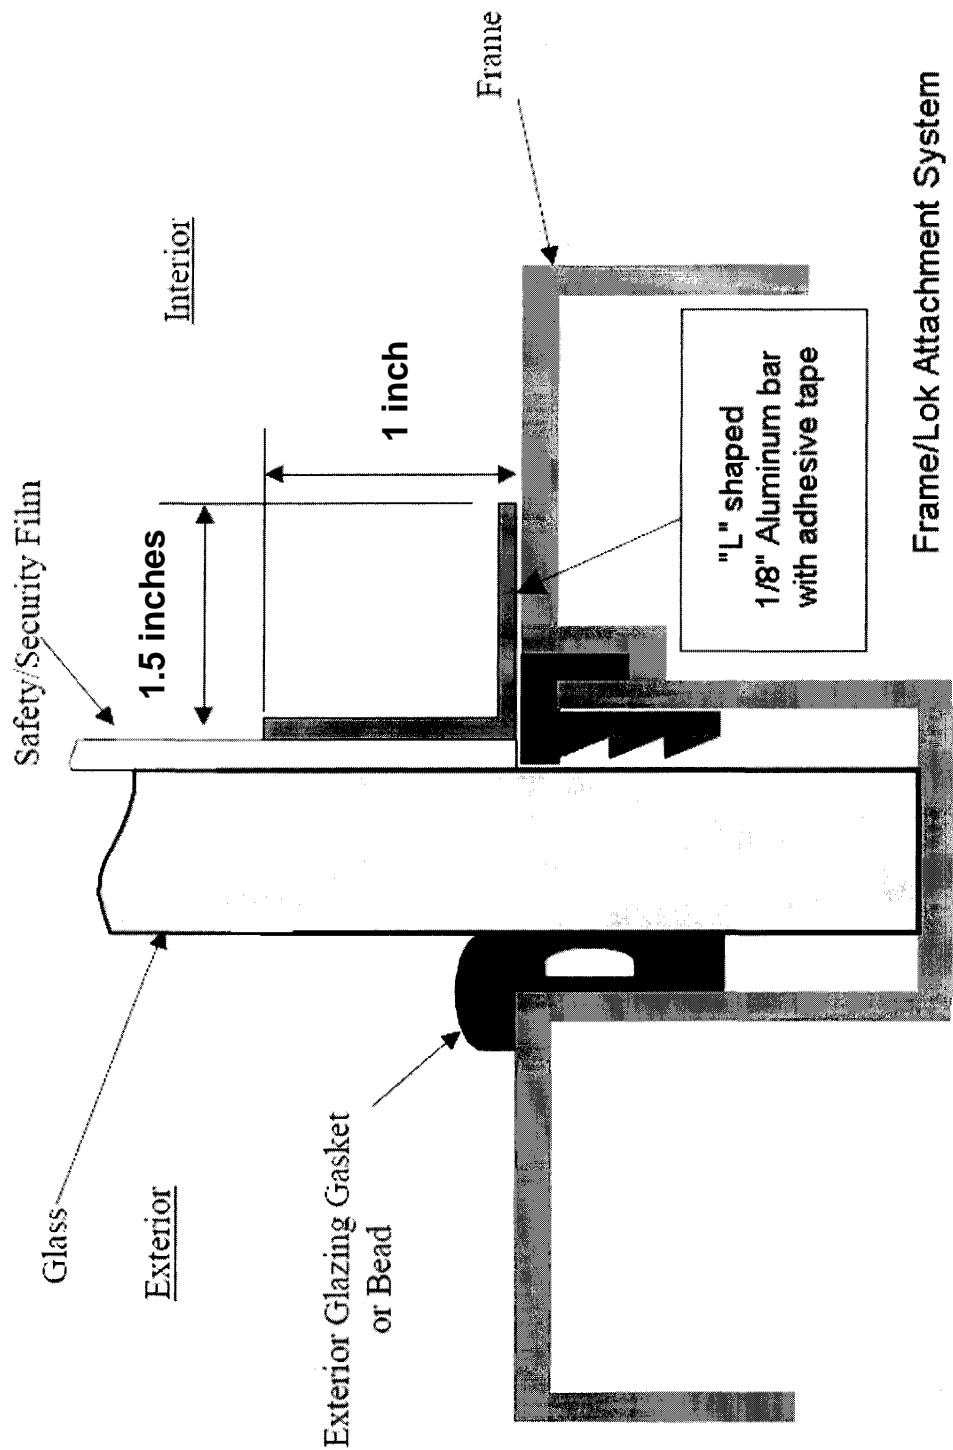
Figure 35. Frame/Lok attachment system.

Tensile Strength PSI (KPa)	140 (965)	ASTM D-412 Die C
Dynamic Shear PSI (KPa) 72 hours dwell stainless steel to paint	120 (827)	NIP-5
Recommended Service Temperature:	40°F to 200° F (-40°C TO 93°C)	
Recommended Application Temperature	60°F to 125°F (16°C to 52°C)	
Elongation %	260	ASTM D-412 Die C

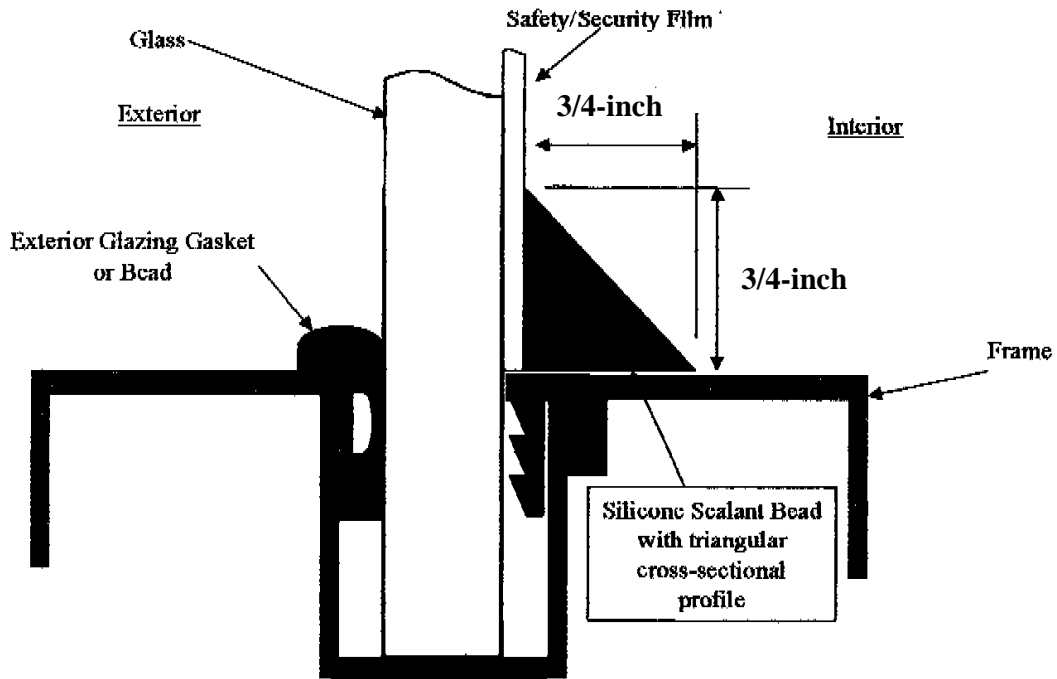
Figure 36. Wet-glazed attachment system.

The results of the test are documented in Tables 2 - 5 and Figures 2 - 17. As tested, all windows can be developed to provide a high level of protection or greater against the GSA Level C (ISC Medium) loading of 4 psi and 28 psi-msec. Quality control during installation is very important and could drastically affect window response. The CPFilms' window number designation for each window tested is provided in Table 6. A sketch of the Frame/lok[®] mechanical attachment system used in Test 1 and 2 is shown in Figure 35. A sketch of the Tremco Proglaze[®] SSG wet-glazed attachment system used in Test 3 and 4 is shown in Figure 36.
