San Diego, California

Tremco Products/Solution:

Camp Pendleton Naval Hospital

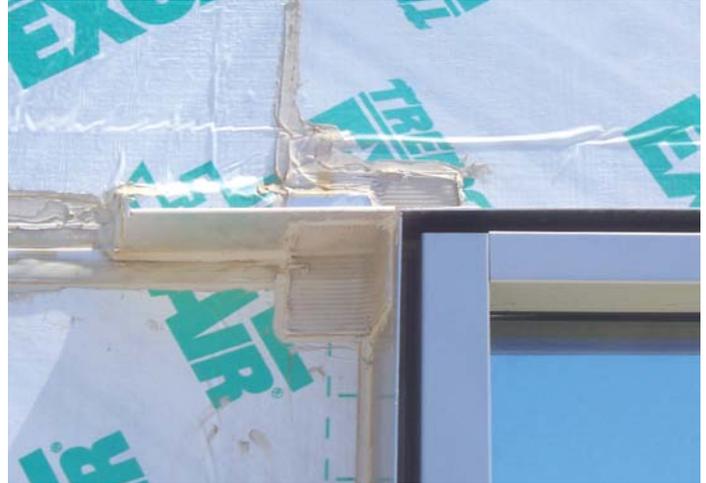
Where the window was set from the plane of the ExoAir 110 Air & Vapor Barrier weather-barrier surface, a silicone "boot" was formed using Tremco's Proglaze ETA 3-D Molded Corners connected to ribbed silicone extrusions and the air barrier with Spectrem 1 Silicone Sealant.

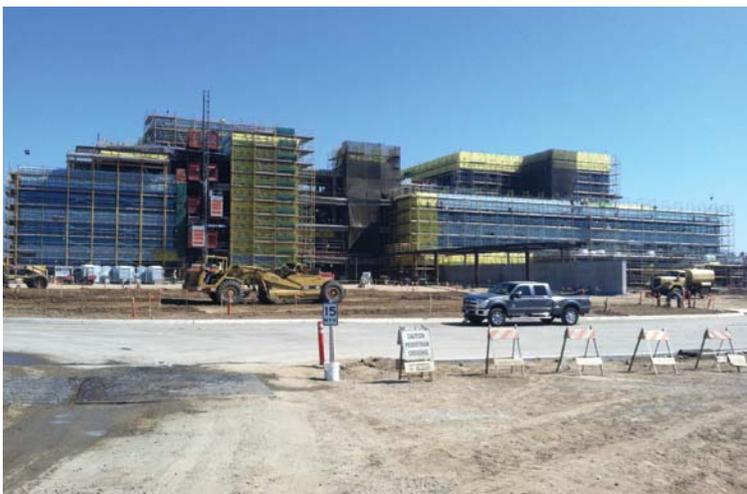
system of stone, terra cotta and metal panels, the air barrier membrane had to be self-gasketing around fasteners. The “pop out” windows created a 90 degree angle from the wall. The ExoAir 110 was wrapped into the opening at each floor at the top of the windows. A 3/4" deflection joint was positioned over the head of each window opening to accommodate a 3/8" movement at each floor level. Proglaze ETA ribbed silicone extrusions were connected around each opening using 3-dimensional molded corners with Spectrem® 1 Silicone Sealant forming a silicone “boot” where the window is set forward from the plane of the weather-barrier surface. A filet bead of Spectrem 1 was placed on the outside of the windows at the corners. The Proglaze ETA extrusions are adhered to the air barrier membrane with Spectrem 1, providing clear proof through the translucent, ribbed sheet of a secure bond and durable connection across the seismic drift joints.

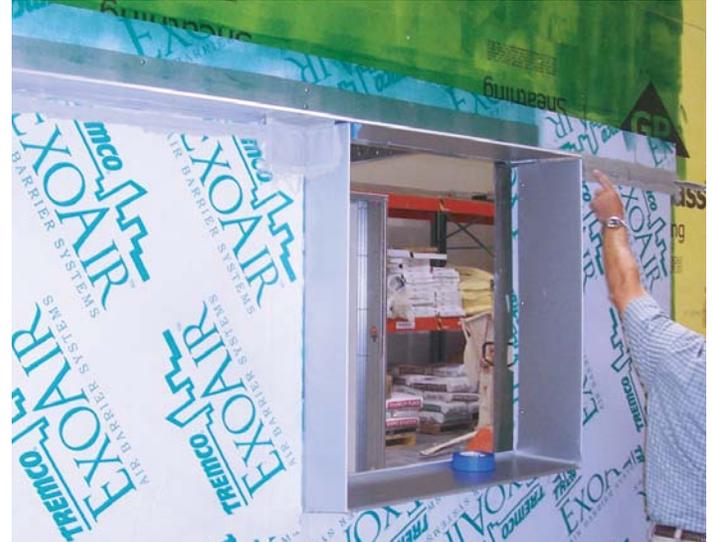
A 30 ft tall mockup was built and submitted to a series of ten tests to determine air leakage under dynamic pressure conditions, ability to withstand structural wind loads, racking and wind-driven rain.

To ensure performance of this design, a mockup was built 50 ft in length and 30 ft tall. Rigorous testing was then conducted to determine air leakage under dynamic pressure conditions and its ability to withstand structural wind loads. A series of ten tests were conducted with racking. The mockup was also tested in accordance with ASTM E331 – *Standard Test Method for Water Penetration of Exterior Windows, Skylights, Doors and Curtain Walls by Uniform Static Air Pressure Difference at 720 Pa (15 psf) Pressure*. The mockup passed all tests.

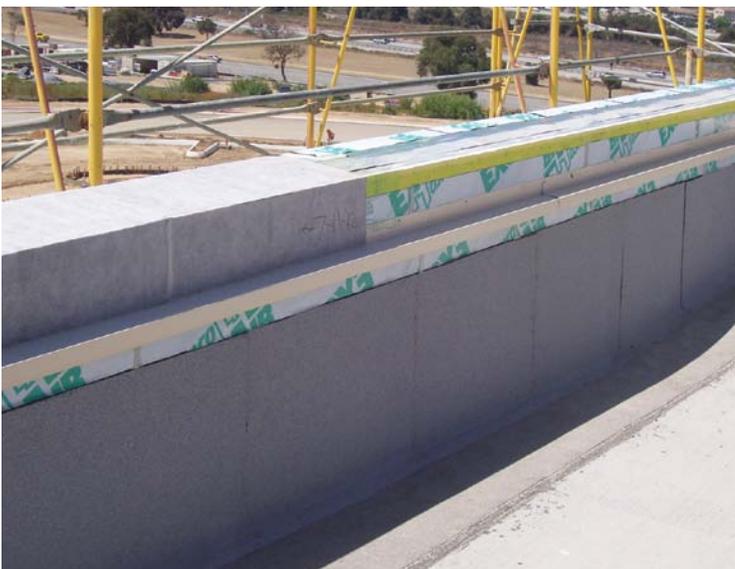
The ExoAir 110 Self-Adhered Air & Vapor Barrier Membrane is carried over the parapet and the ExoAir HTF is applied over it to connect them, providing continuity from the roof to wall.

To provide the compatible continuity required on the replacement hospital, Tremco's TREMproof® 6100 Hot Rubberized Asphalt with PowerPly modified bitumen membrane heavy-duty protection course and TREMDrain drainage board used on the roof deck was tied into the parapet wall with ExoAir HTF High Heat Membrane, which would lap over the membrane and be protected with a metal flashing. Thorough testing was also conducted on the roofing systems to ensure watertight integrity and performance.

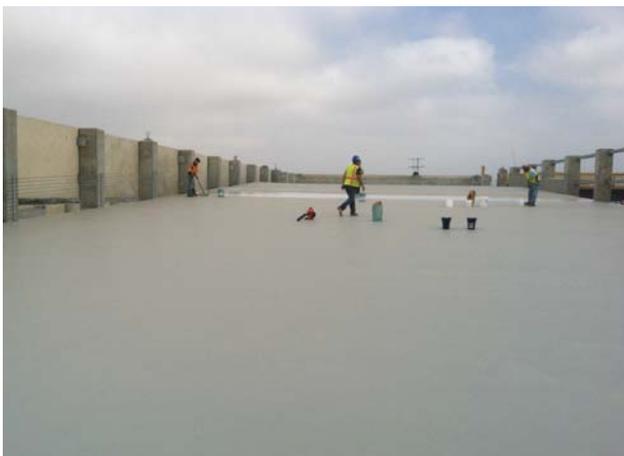
A 1500-space, multi-level parking structure is also part of the project and is connected by a bridge to the hospital. Tremco's Vulkem® low-odor, low-VOC deck coating system is being used on the two top decks due to its tenacious adhesion to concrete surfaces and its ability to retain its integrity even if substrate movement causes hairline cracks. The tough-curing polyurethane system has outstanding elongation and recovery to expand and contract with substrates, providing outstanding protection against automotive oils and fluids leaking through cracks onto lower decks.
