**Location:**

**Cleveland, Ohio**

**Tremco Product System:**

## **Cleveland State University, Rhodes Tower**

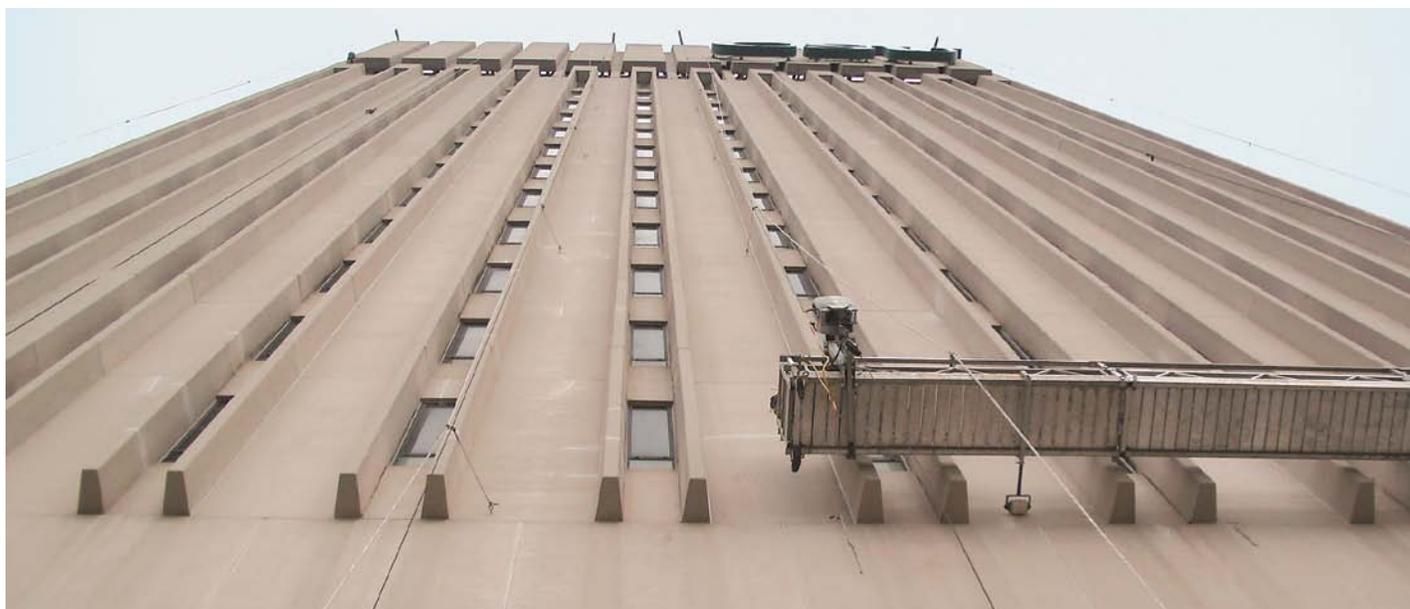
Though determining the size needed was difficult from the ground, illmod 600 is available in a variety of sizes so it was possible to mix and match the tape to fit the joints so everything was consistent throughout.

For Rhodes Tower, 40,000 linear feet of illmod 600 were specified for joint repair in the exterior panels. While the great height of the tower made it somewhat difficult for contractors to determine the tape size needed from the ground, illmod 600 is available in a variety of sizes, so contractors were able to mix and match the tape to fit the joints in a consistent manner. Tape rolls range from almost nine feet to 32 feet in length, depending on the width and thickness of the tape.

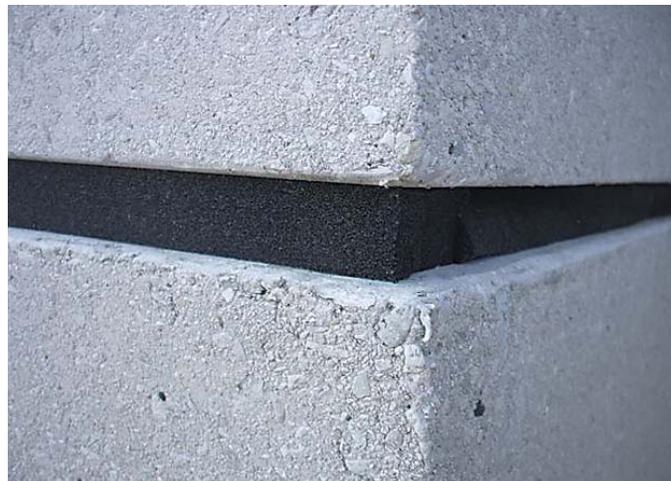
The illmod 600 is pressed in place from one-fourth to one-half inch deep and expands to fill the joint, sealing small imperfections.

Contractors easily positioned and affixed illmod 600 to the tower's exterior joints by pressing the pressure-sensitive adhesive side in place from one-fourth to one-half inch deep. Once the tape was positioned, the material self-expanded to fill the joints and seal small imperfections, forming a

permanently elastic, weather-tight seal. There was no wait for the material to cure in cold weather, and rain wasn't an issue because illmod 600 doesn't need a dry surface. The time it takes for the tape to fully expand depends on the temperature: at 37°F, full expansion takes five hours; at 68°F, it takes eight minutes; and at 104°F, it fully expands in one minute.

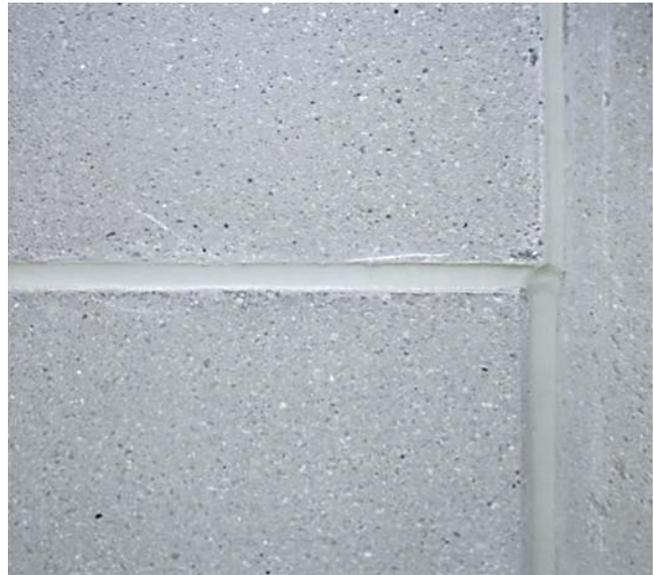
**Spectrem 2 Silicone Sealant was applied over the illmod 600 for a weathertight system with increased assurance of prolonged productive life plus thermal and acoustical benefits.**

Once the illmod 600 had fully expanded, Tremco's Spectrem® 2 Silicone Sealant was applied over it to eliminate any deficiencies that could compromise the building envelope by allowing air and moisture to enter. There is no need for primer over the illmod 600 tape. A medium modulus, one-part, high-performance, neutral cure silicone sealant, Spectrem 2 is used in a variety of caulking and glazing applications. Because it is formulated to ensure weather-tight connectivity, it is particularly appropriate as a weather seal and tensile bead in two-sided structural glazing systems.

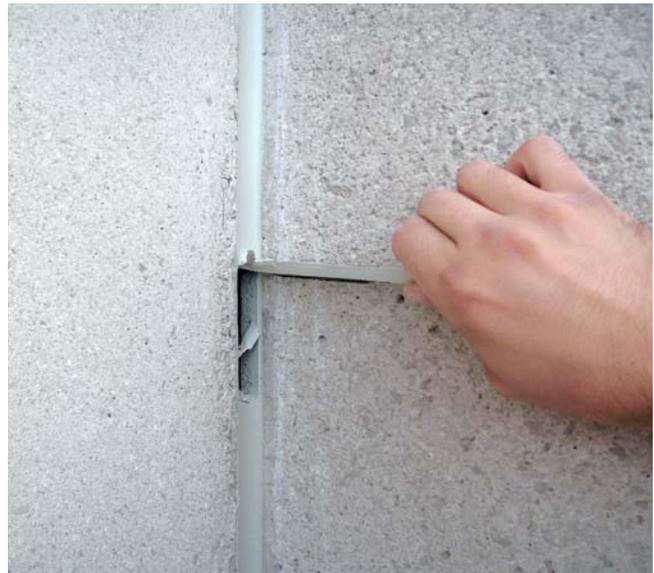
**Adhesion testing was performed on every lift of the building, which also allowed for review of the illmod 600 installation.**

To ensure performance and quality, the high-performance sealant system was first tested using the ASTM tab adhesion field test. This ensured that the sealant was adhering and performing properly. The test was performed on every lift of the building which also allowed for review of the installation of the illmod 600.
